California Commercial Property Inspectors

Commercial Inspection

Inspected on Fri, Oct 18 2019 at 1:35 PM

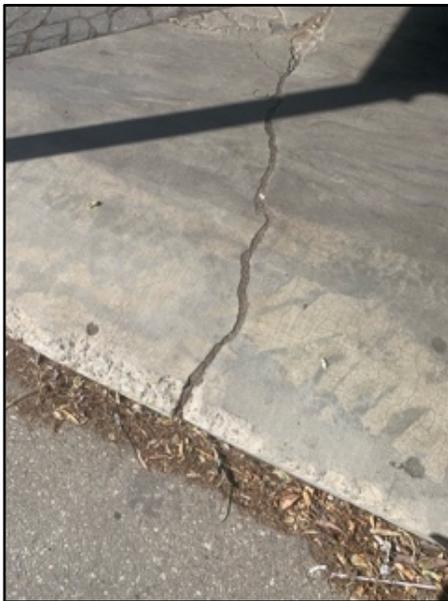
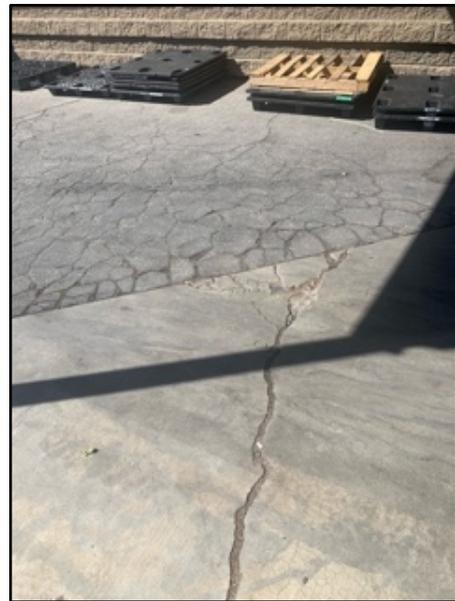
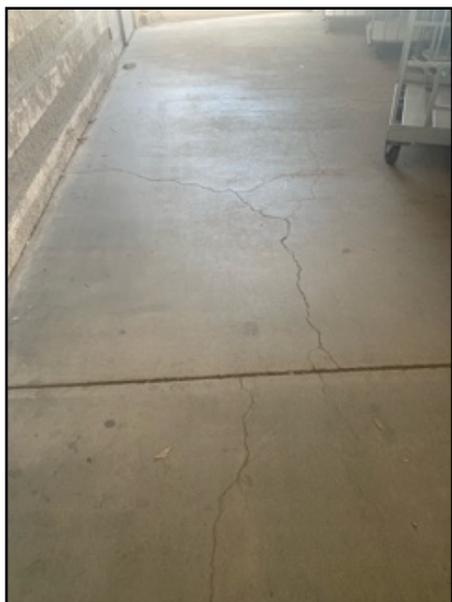
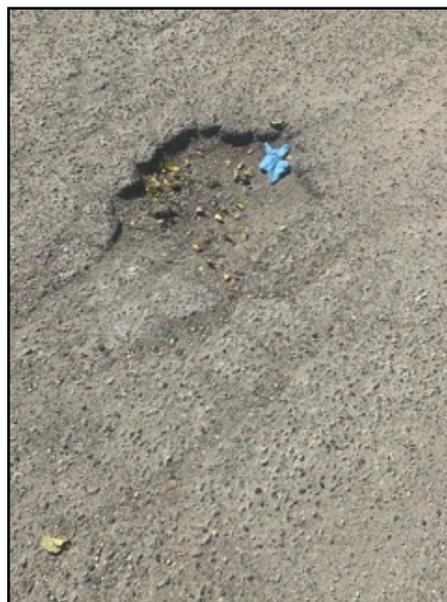
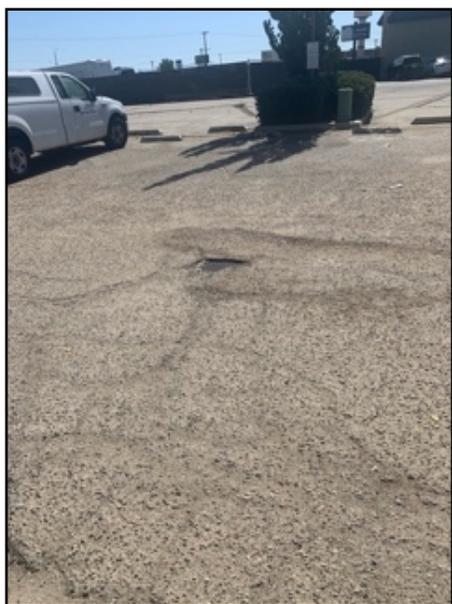
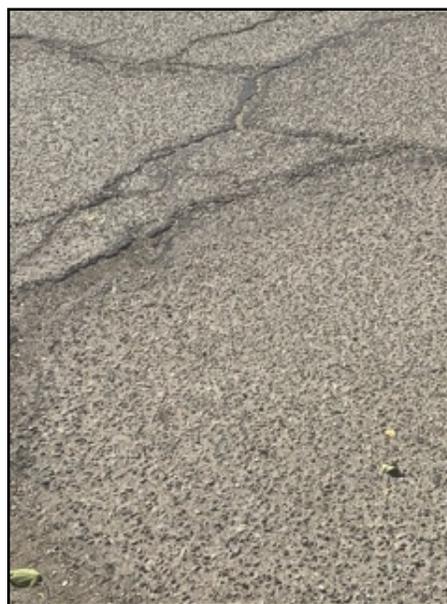
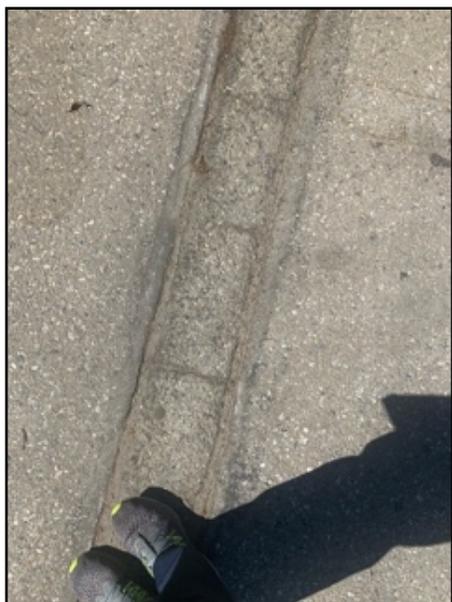
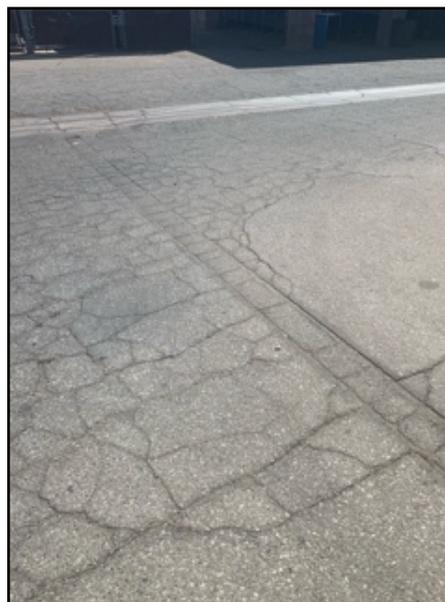
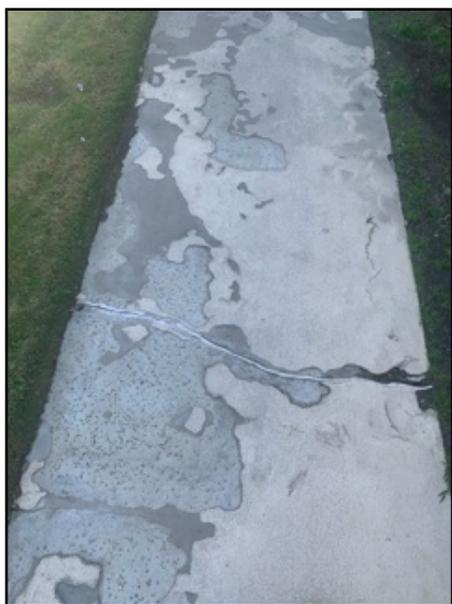
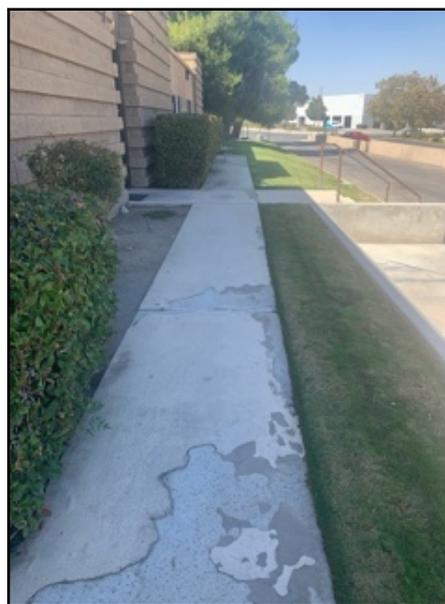
Cracks, holes, settlement, heaving and/or deterioration were found on the walkway. The walkway is uneven and is a trip hazard Recommend that qualified contractor repair as necessary.

1) Cracks, holes, settlement, heaving and/or deterioration were found on the walkway. The walkway is uneven and is a trip hazard Recommend that qualified contractor repair as necessary.

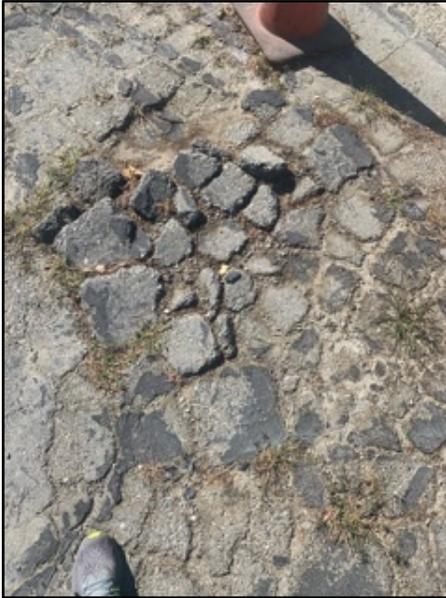
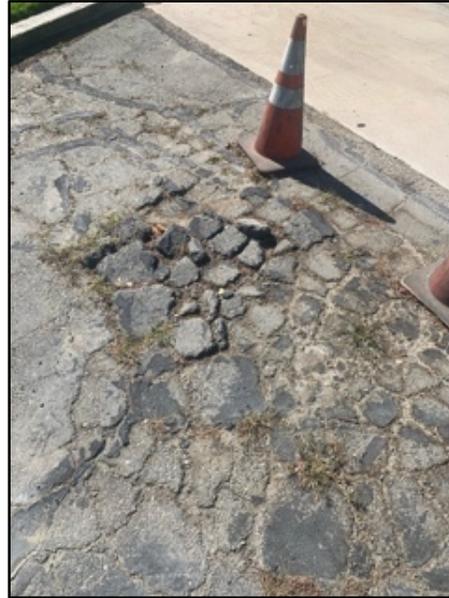
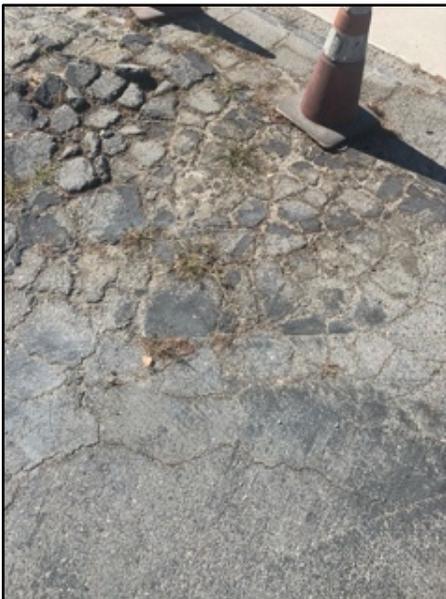
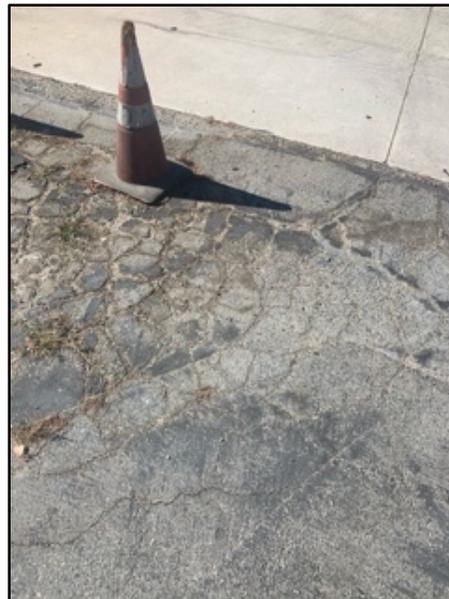
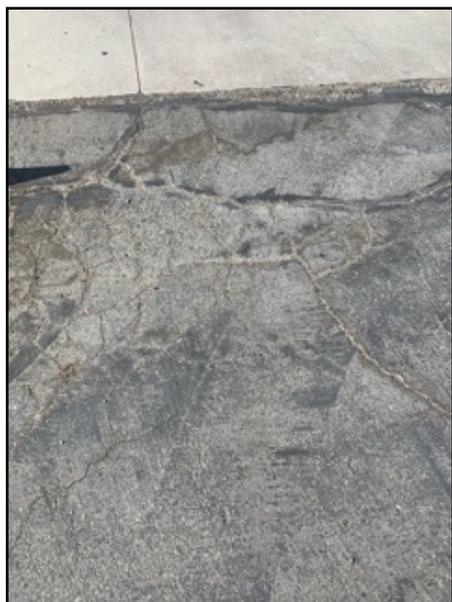
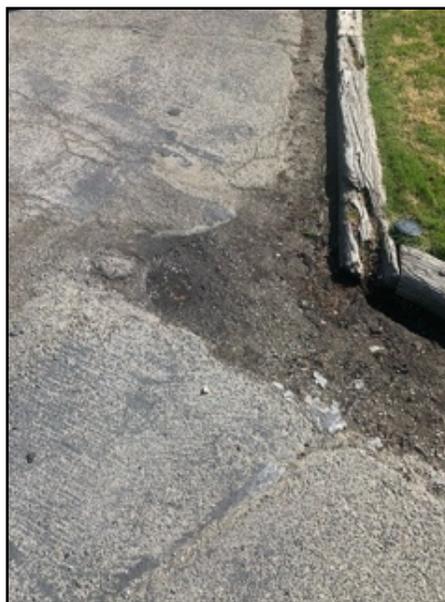
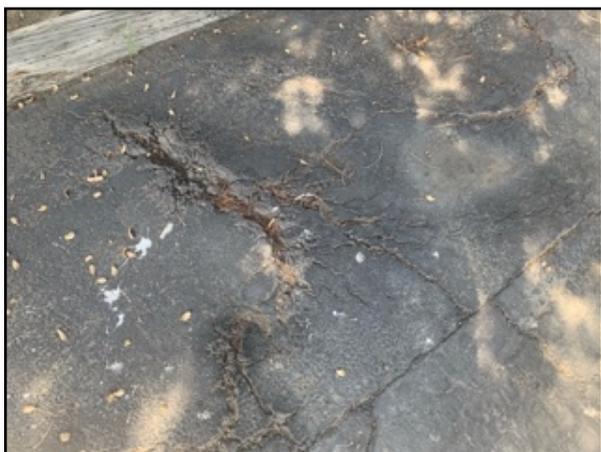
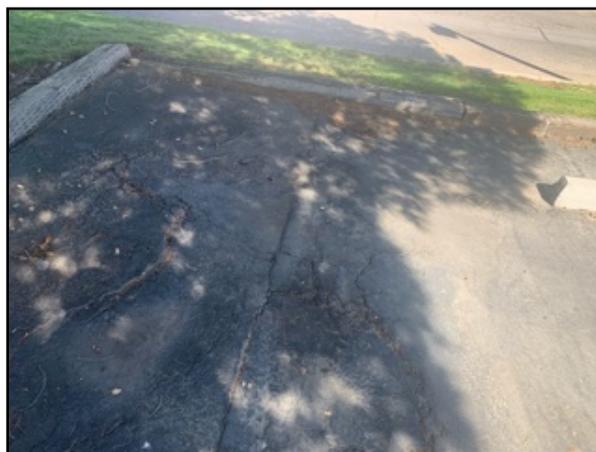
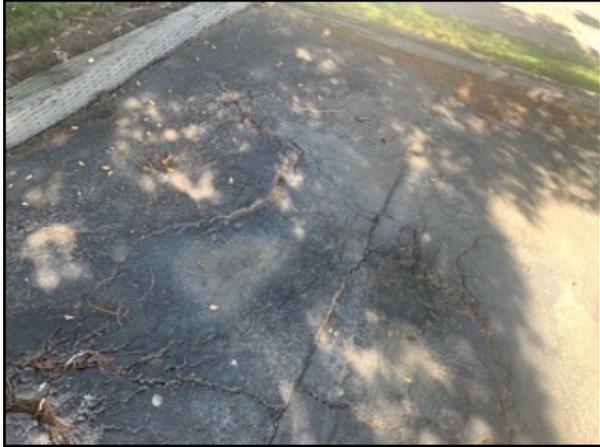
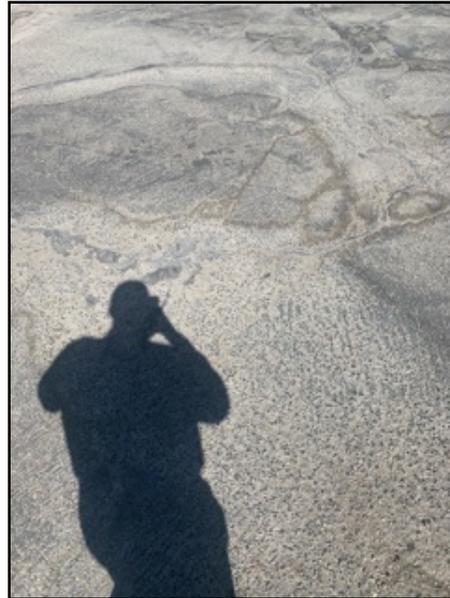
Cracks, holes, settlement, heaving and/or deterioration were found in the driveway. Trip Hazard. Recommend that qualified contractor repair as necessary.

Recommend having the main line scoped. Due to the cracks in the parking lot

2) Cracks, holes, settlement, heaving and/or deterioration were found in the driveway. Trip Hazard. Recommend that qualified contractor repair as necessary.

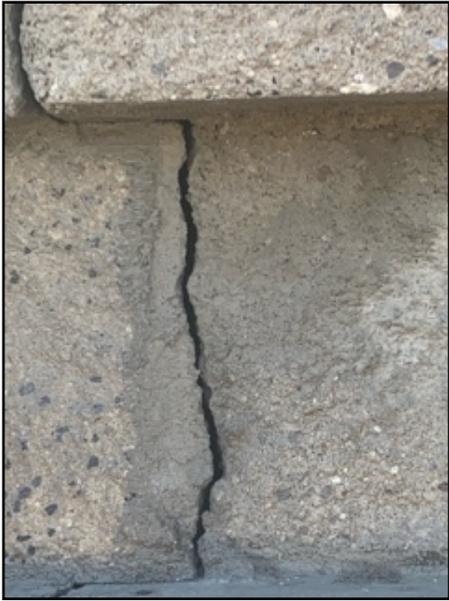
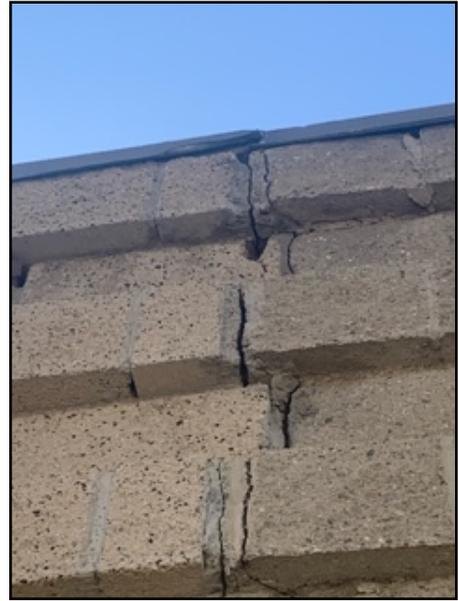
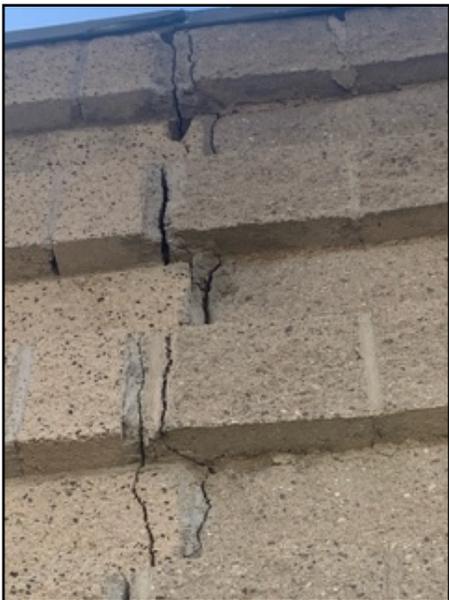
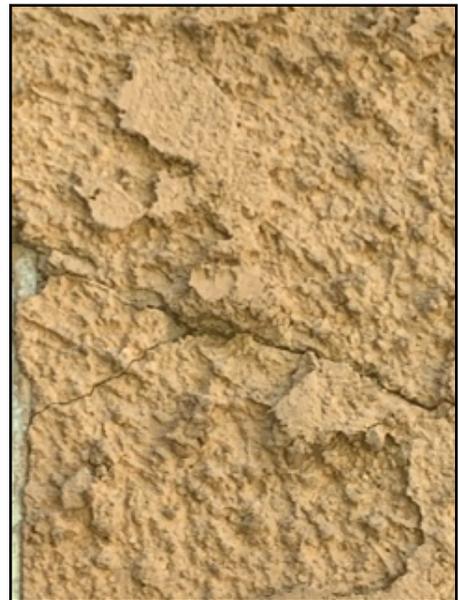
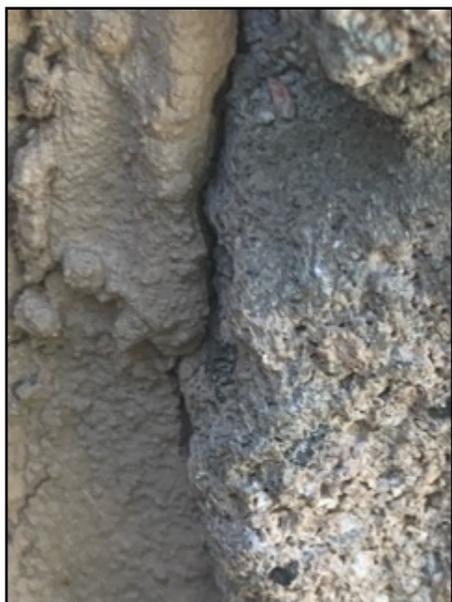
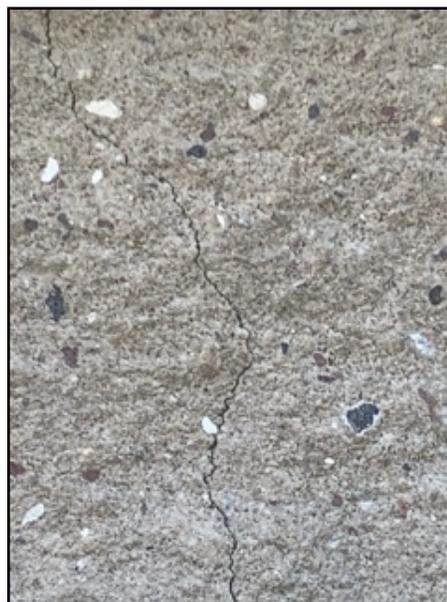
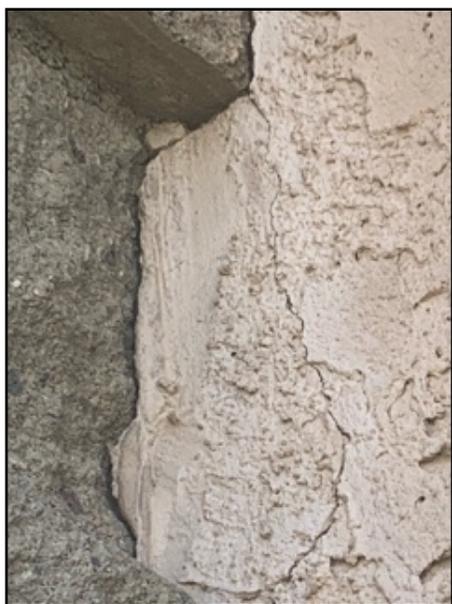
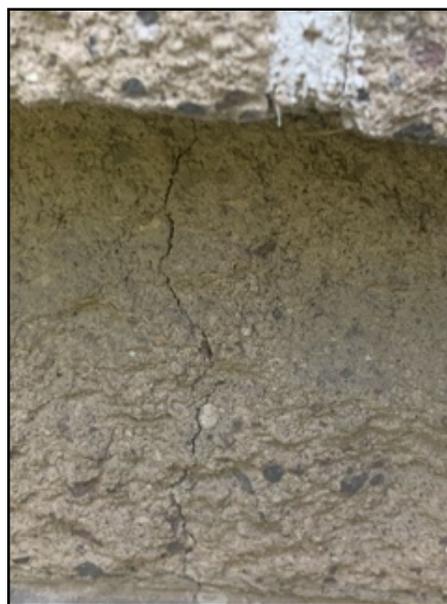
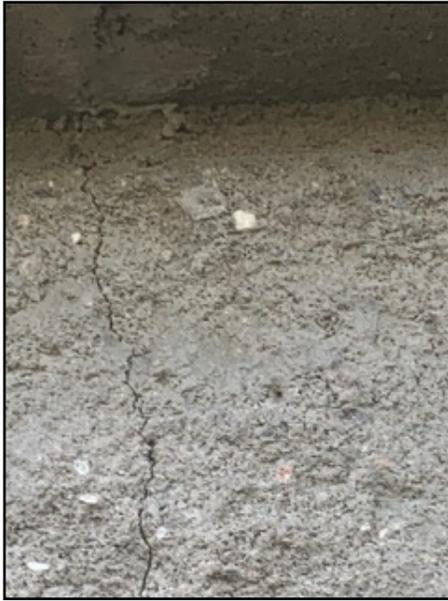
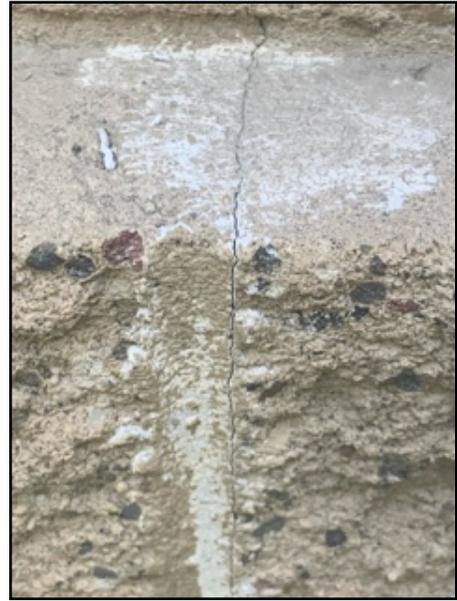
Cracks, deterioration and/or damage were found in one or more areas of the exterior finish. In damp climates, moisture can enter cracks or damaged areas and further deteriorate the covering. Also the wall behind the covering can become damaged from moisture. Recommend that a qualified contractor repair or replace covering as necessary.

3) Cracks, deterioration and/or damage were found in one or more areas of the exterior finish. In damp climates, moisture can enter cracks or damaged areas and further deteriorate the covering. Also the wall behind the covering can become damaged from moisture. Recommend that a qualified contractor repair or replace covering as necessary.

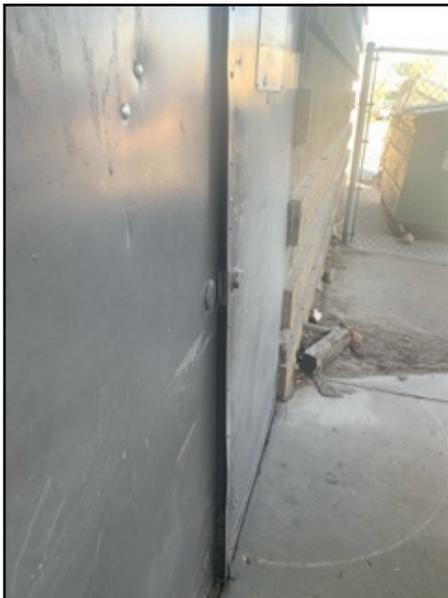
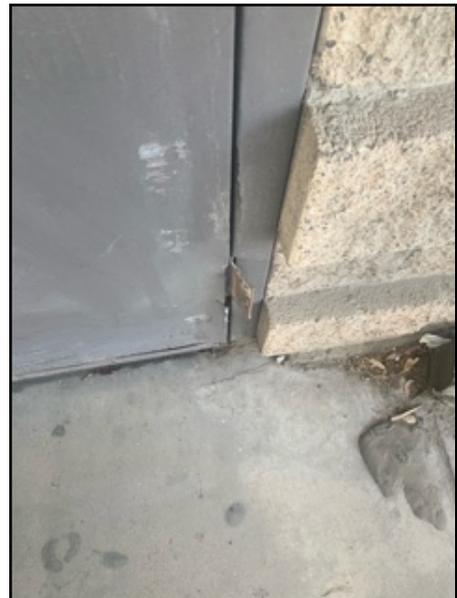
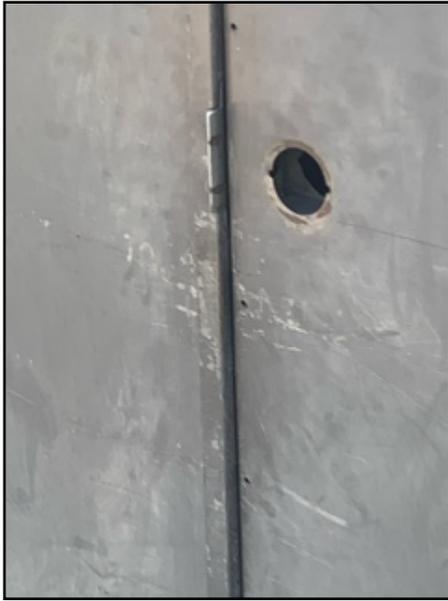
Major damage/deterioration

One or more exterior doors had major damage and/or deterioration.

Cracks, deterioration and/or damage were found. In damp climates, moisture can enter cracks.

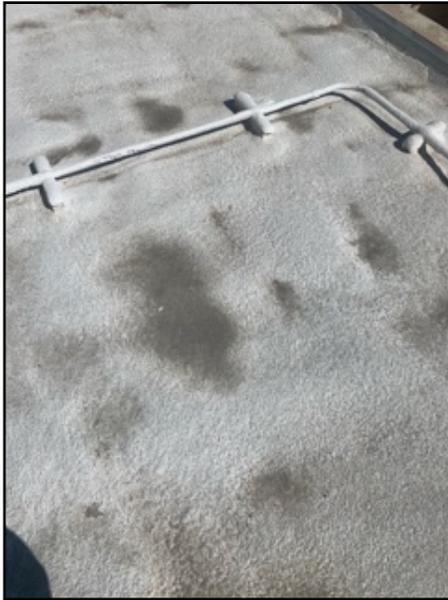
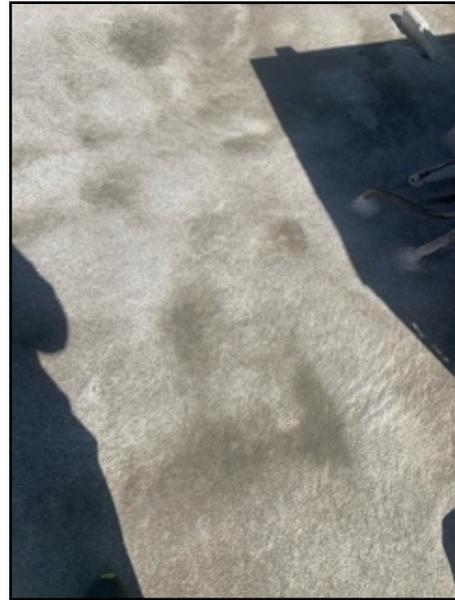
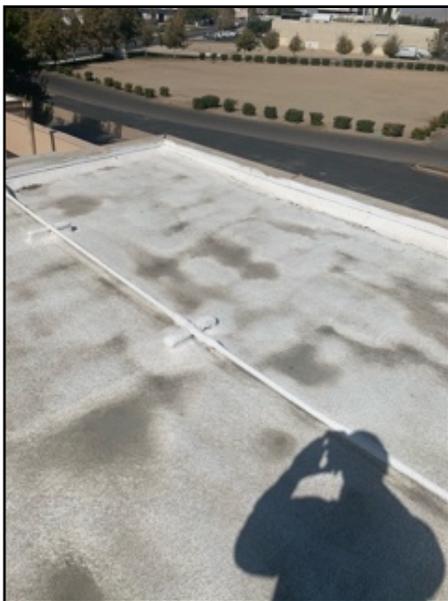
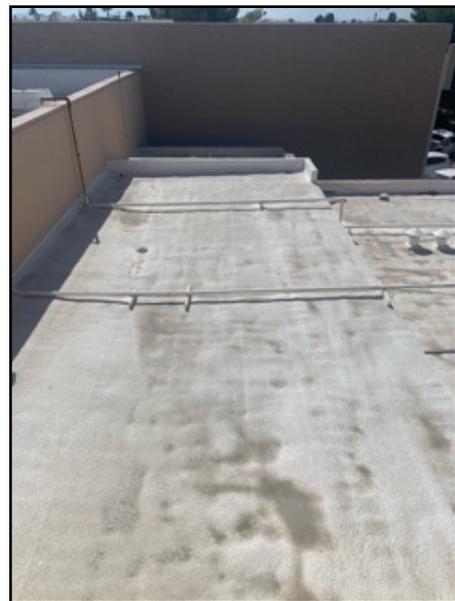
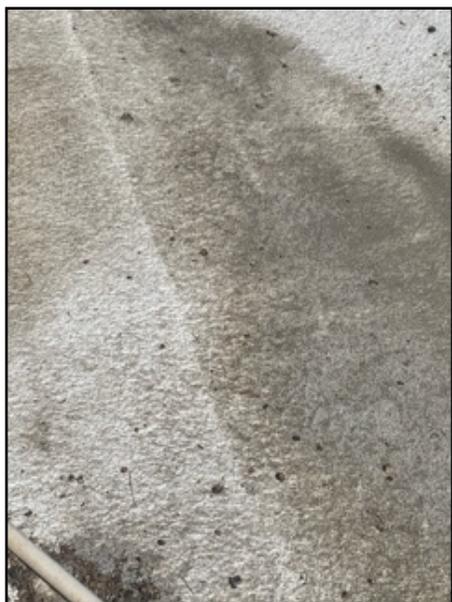
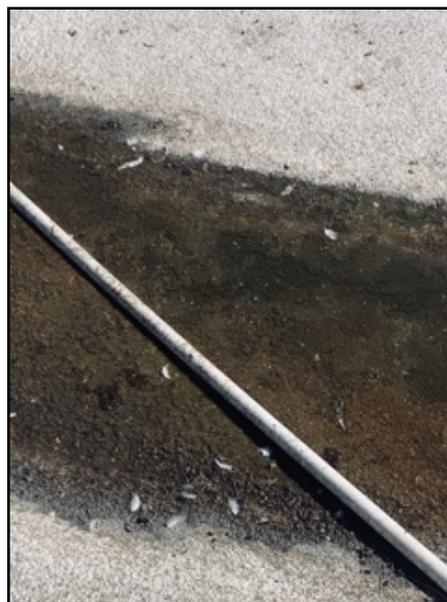
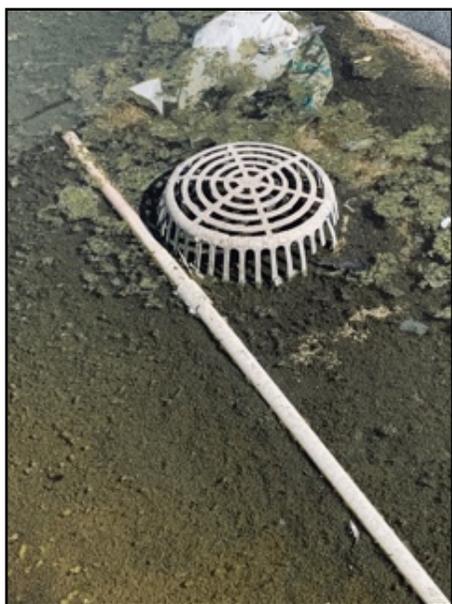
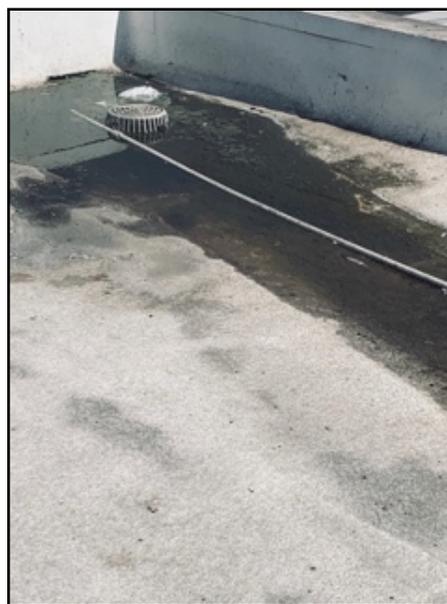
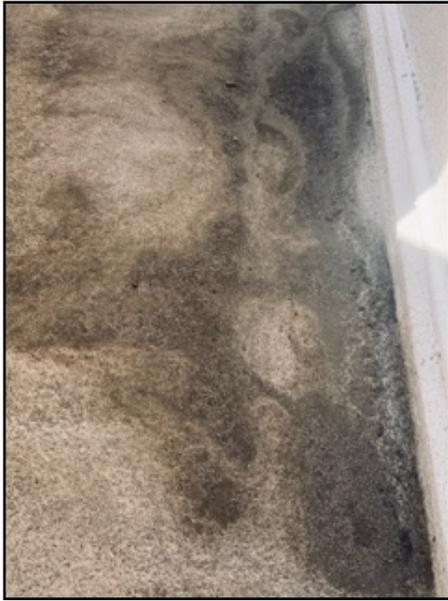
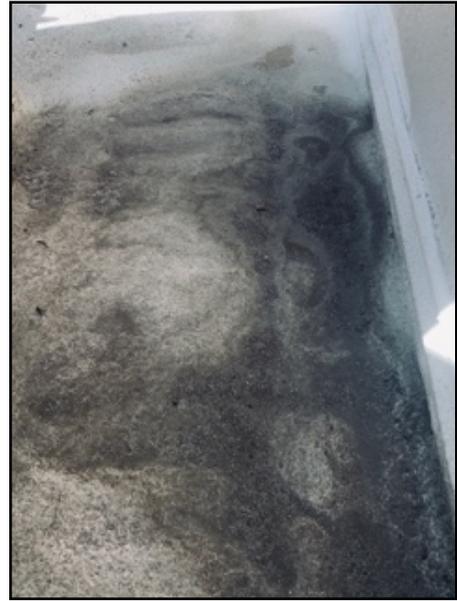
The roof covering is ponding. Water ponding act as a magnifying glass on the roof under the pond, which increases the damaging ultraviolet exposure of that area of the roof. Contribute to the photo-oxidation (i.e. premature deterioration) thus compromising the integrity of the roof system.

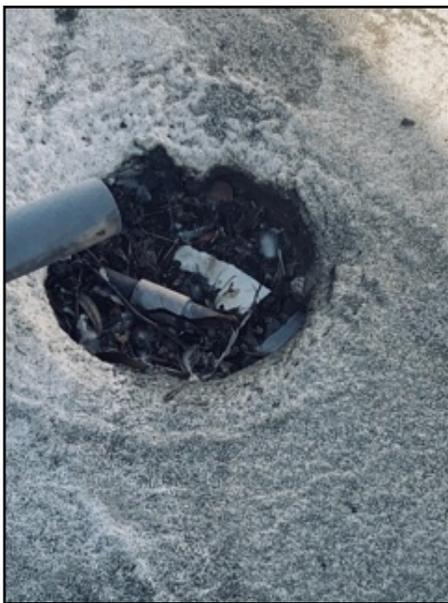
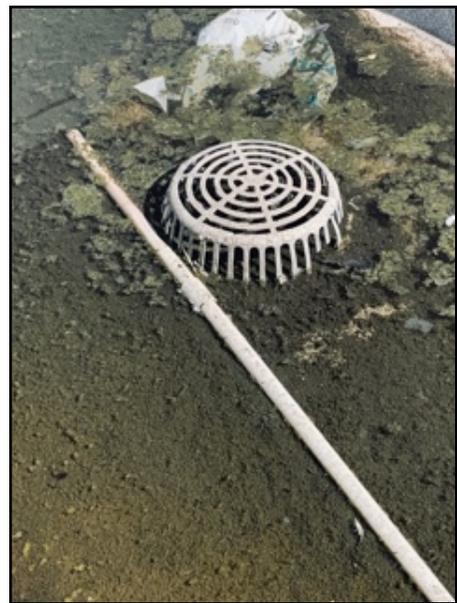
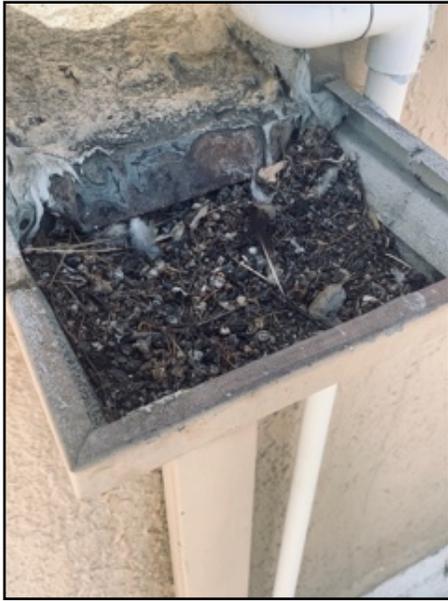
Significant amounts of debris have accumulated in drain over garage. It can overflow and cause water to come in contact with the building exterior, or water can accumulate around the foundation. This is a conducive condition for wood-destroying organisms.

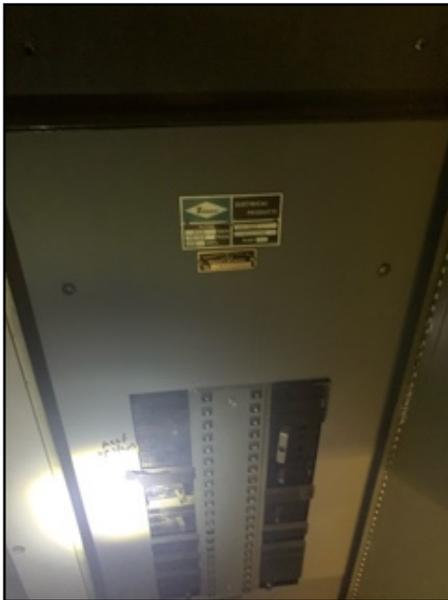
Figure 7-1

Panel was manufactured by the Zinsco company. These panels and their circuit breakers have a history of problems including bus bars made from aluminum that oxidize and corrode, breakers that don't trip under normal overload conditions, and breakers that appear to be tripped when they're not. This is a potential safety hazard for shock and/or fire. Recommend that a qualified electrician carefully evaluate all Zinsco brand panels and components and make repairs as necessary. Consider replacing Zinsco panels with modern panels that offer more flexibility for new, safer protective technologies like arc fault circuit interrupters (AFCIs).

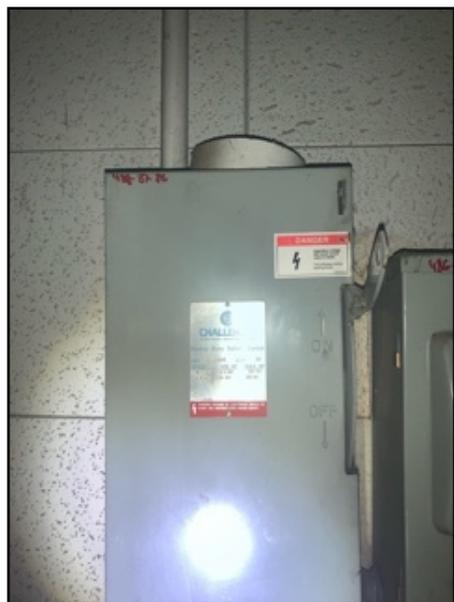
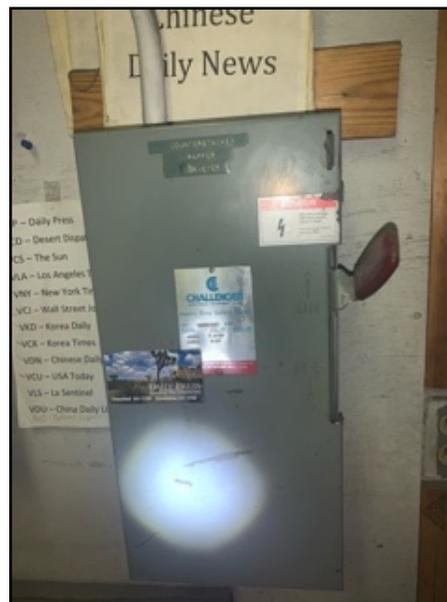
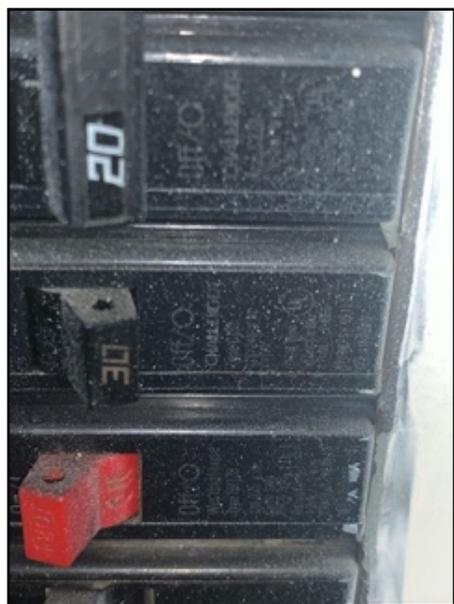
Challenger breakers were installed in hundreds of thousands of homes during the 80's and 90's.

Over the years it was discovered that 2 types of circuit breakers manufactured by Challenger are overheating under NORMAL conditions at the connection point to the busbar. This causes expansion and contraction which in turn causes arcing between the circuit breaker and the busbar damaging both. This continues over time until these components actually melt down completely, causing hazardous conditions such as fire and/or shock hazard.

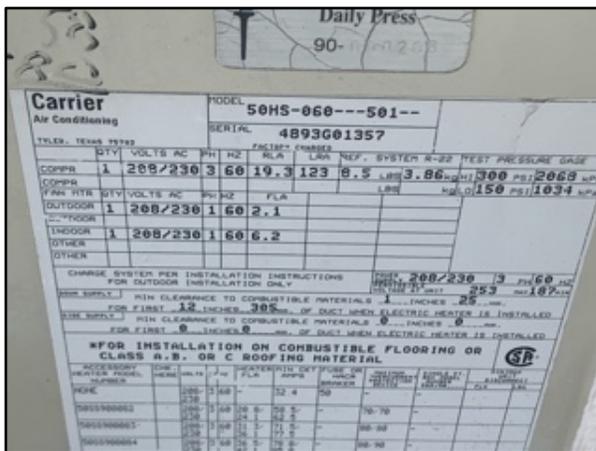
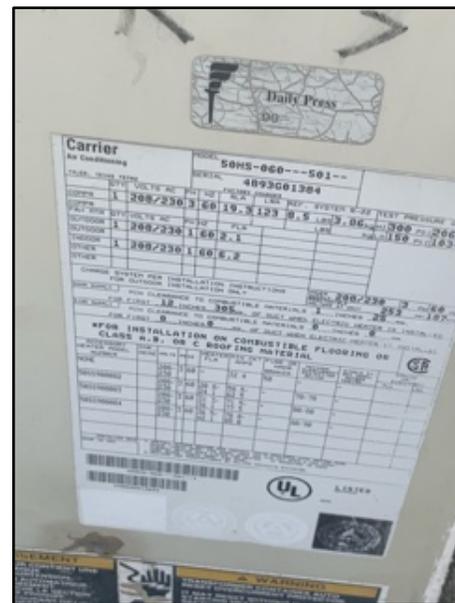
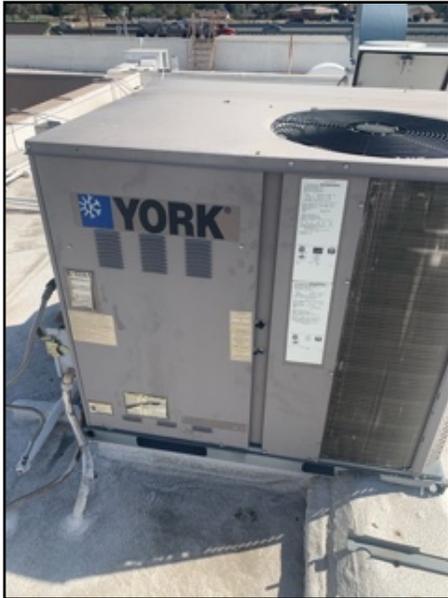
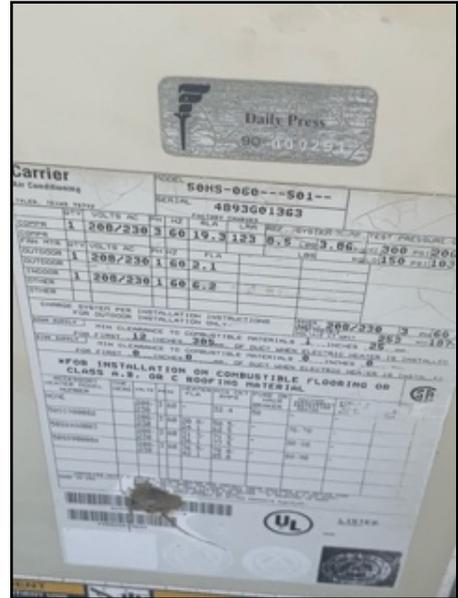
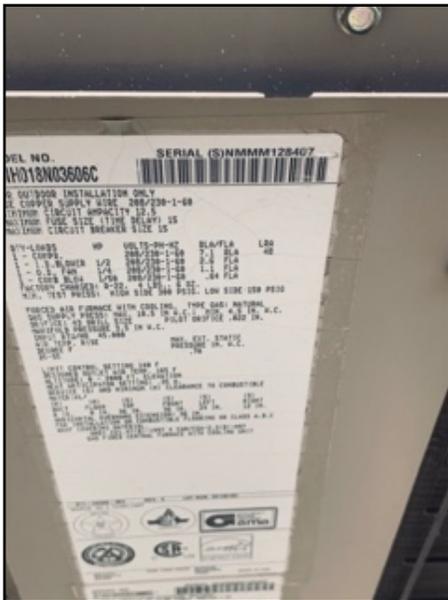
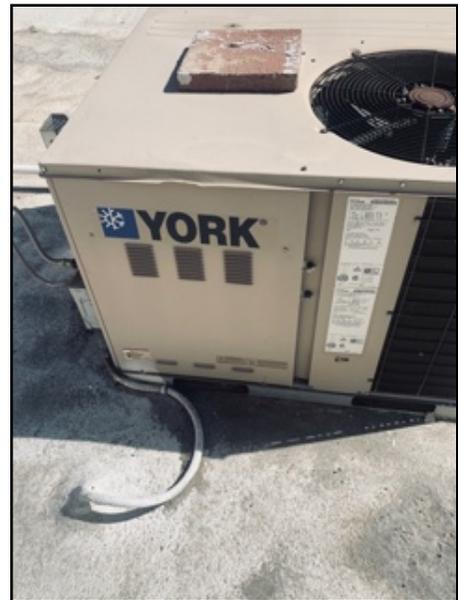
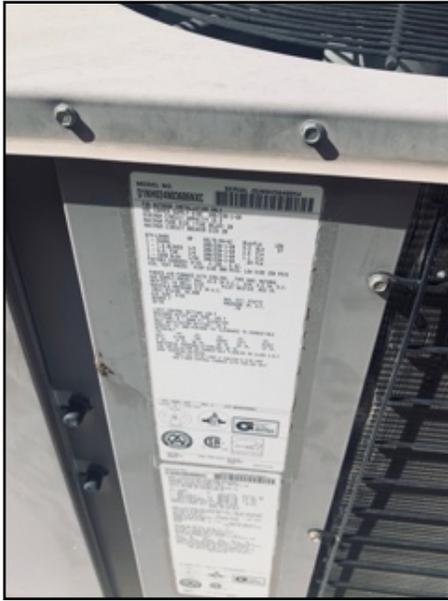
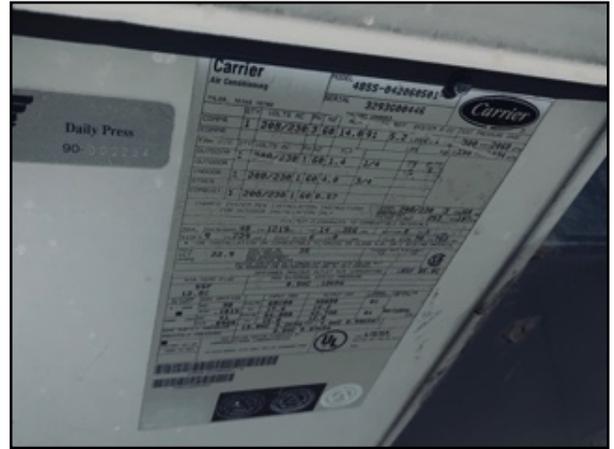
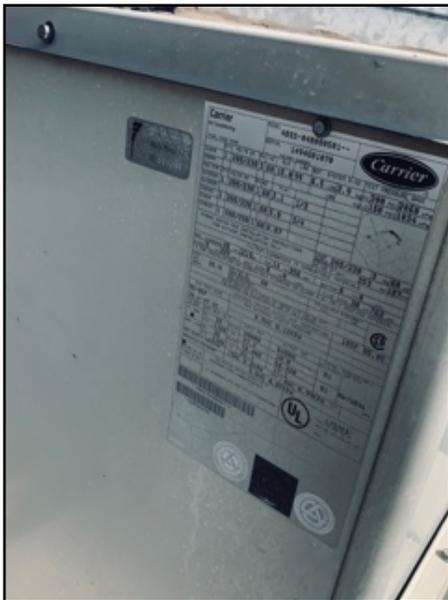
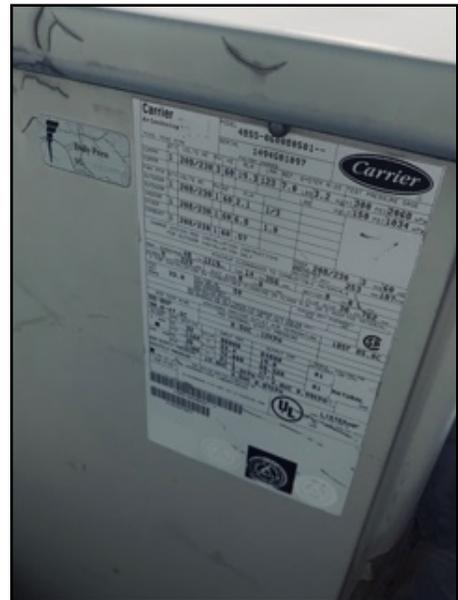
All A/C packaged units are older than 15 years old and half of the units are older than 20 years old. Due to Victorville's extreme heat and age of units recommend replacing. The estimated useful life for most packaged units is 15-20 years. This packaged unit appeared to be near this age and/or its useful lifespan and may need replacing or significant repairs at any time. Recommend budgeting for a replacement in the near future. HVAC System did work at time of inspection. Recommend HVAC professional service units. A/C did cool the building at time of inspection.

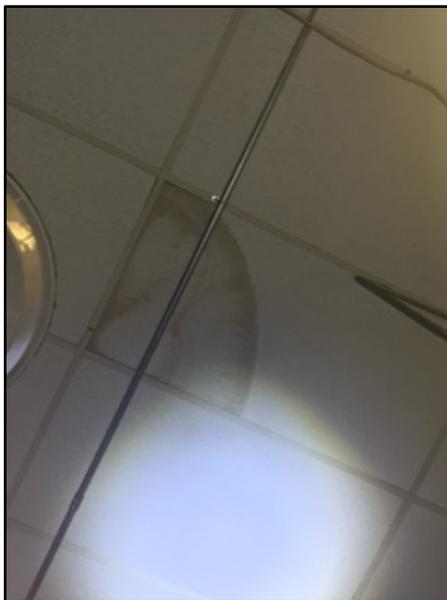
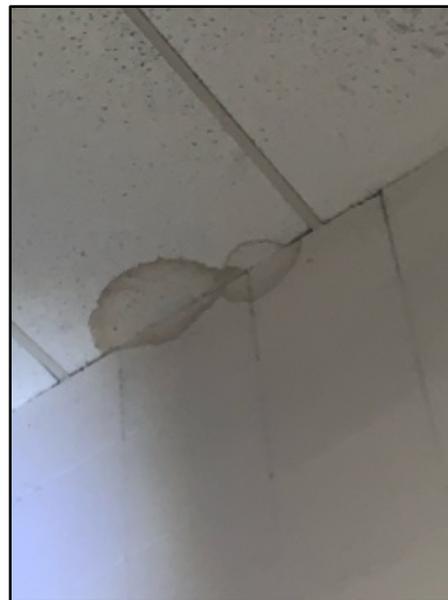
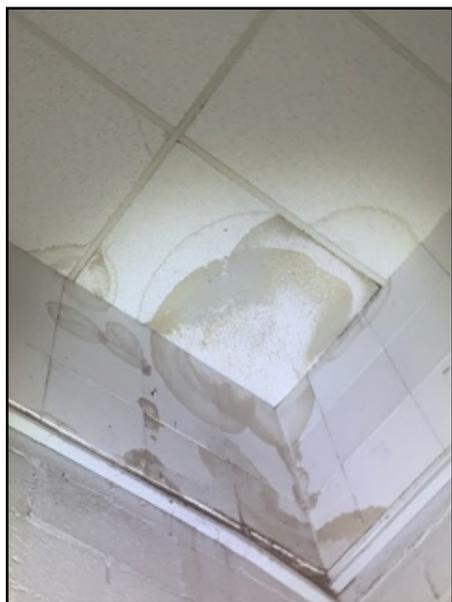
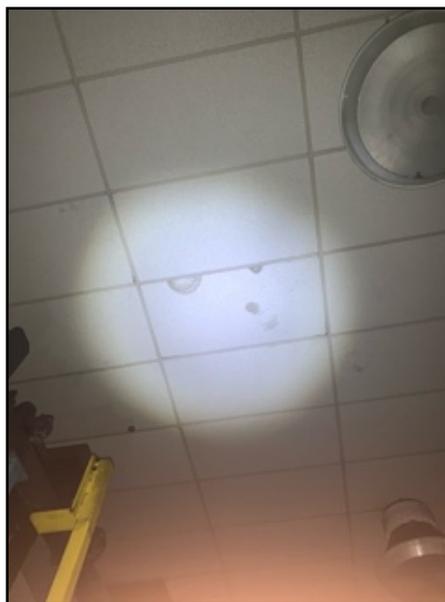
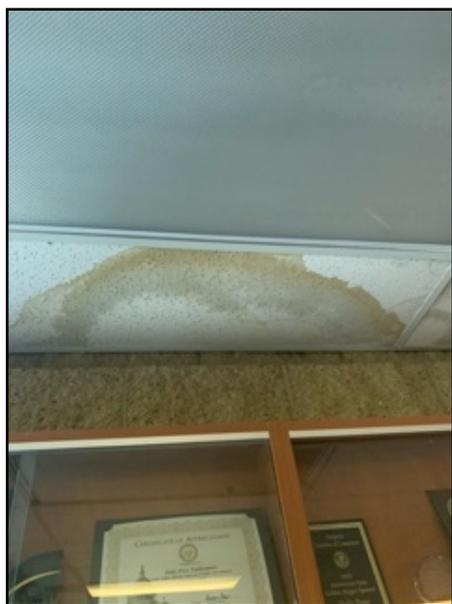
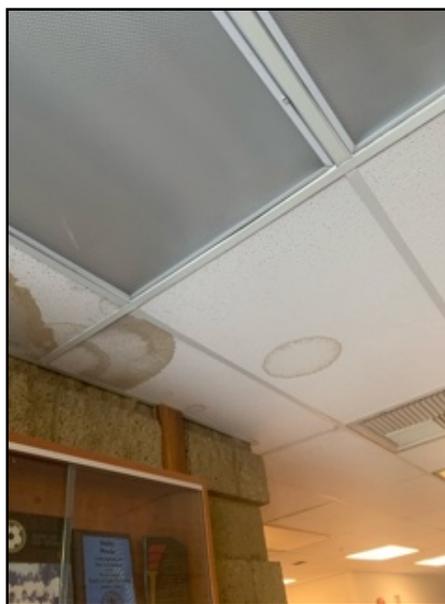
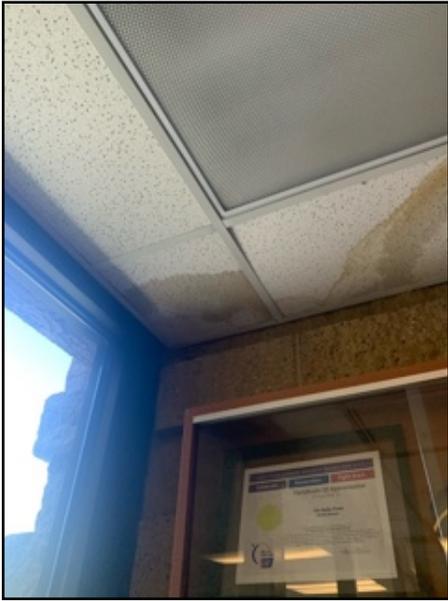
Moisture stains found on the ceiling.
