# California Commercial Property Inspectors

## Commercial Inspection

**39471 Big Bear Blvd**

Inspected on Thu, May 19 2022 at 12:32 PM

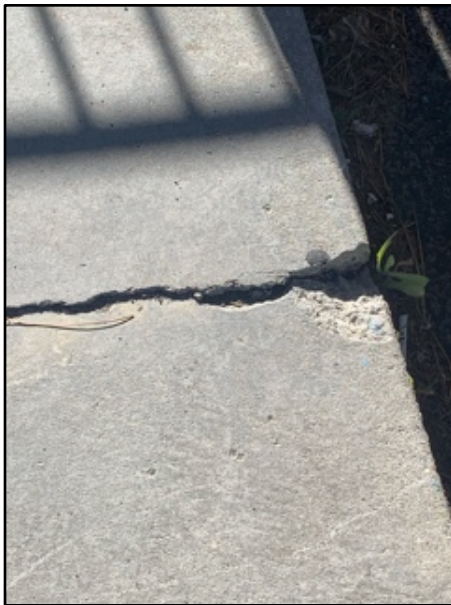
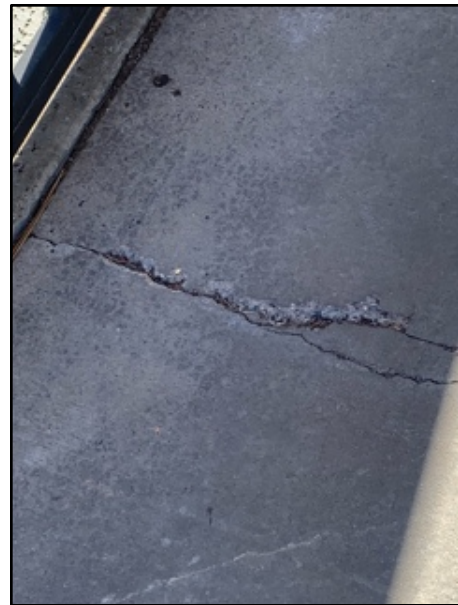
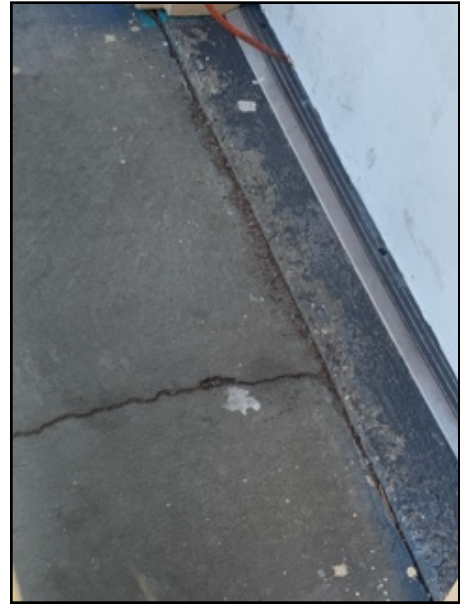
1) Safety Hazard. Cracks, holes, settlement, heaving and/or deterioration were found on the walkway. The walkway is uneven and is a trip hazard Recommend that qualified contractor repair as necessary.

Safety Hazard. Cracks, holes, settlement, heaving and/or deterioration were found on the walkway. The walkway is uneven and is a trip hazard Recommend that qualified contractor repair as necessary.

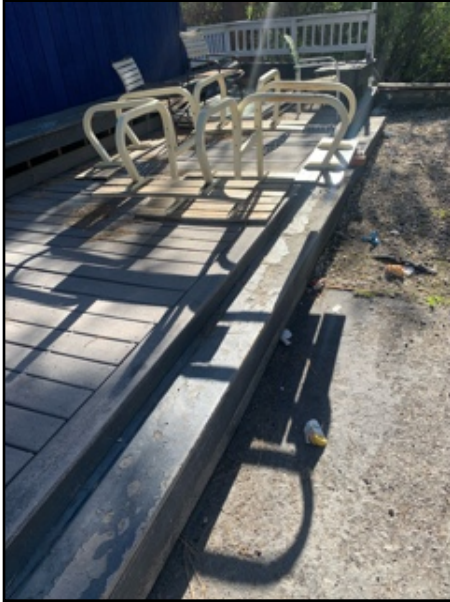
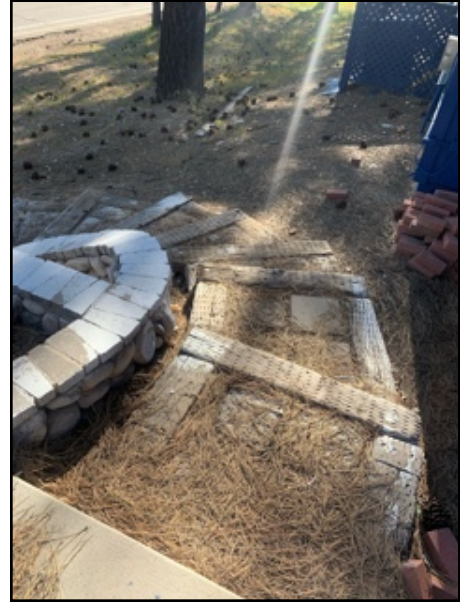
2) Recommend adding handrails for steps. Steps exceed 30 inches from the ground.

Recommend adding handrails for steps. Steps exceed 30 inches from the ground.

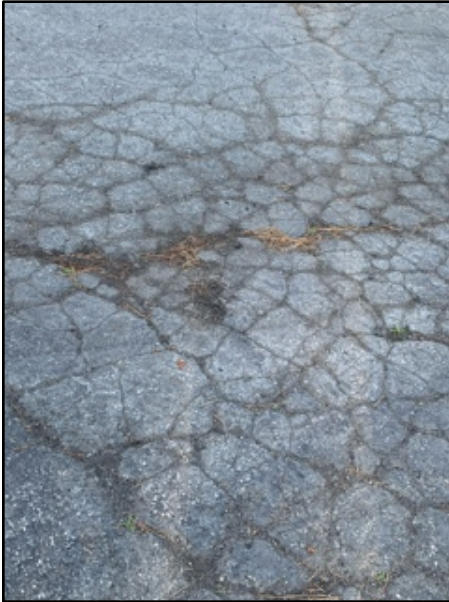
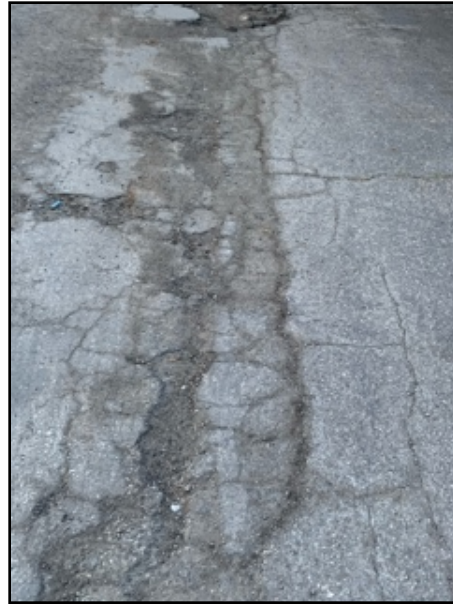
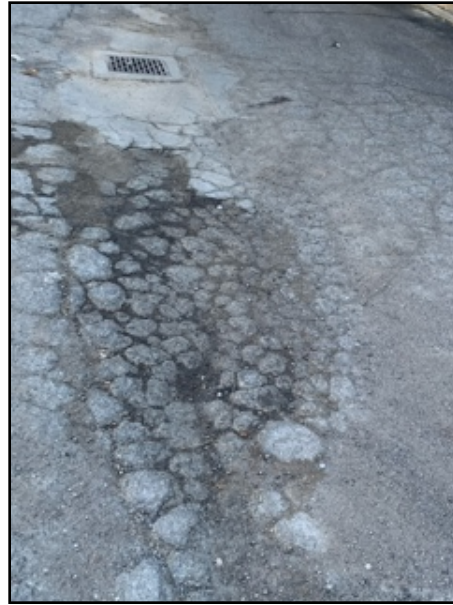
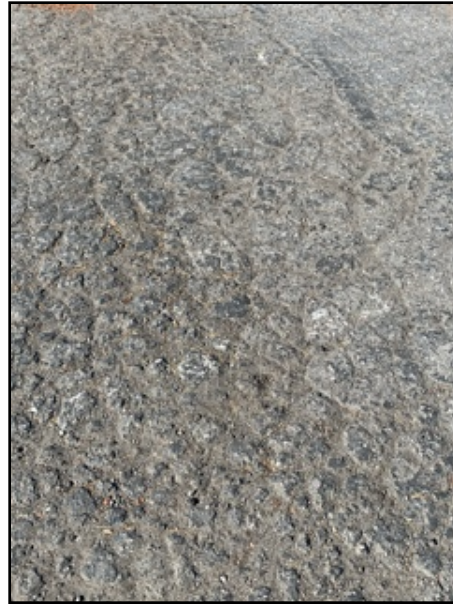
3) Cracks, holes, settlement, heaving and/or deterioration were found in the driveway. Trip Hazard. Recommend that qualified contractor repair as necessary.

Cracks, holes, settlement, heaving and/or deterioration were found in the driveway. Trip Hazard. Recommend that qualified contractor repair as necessary.

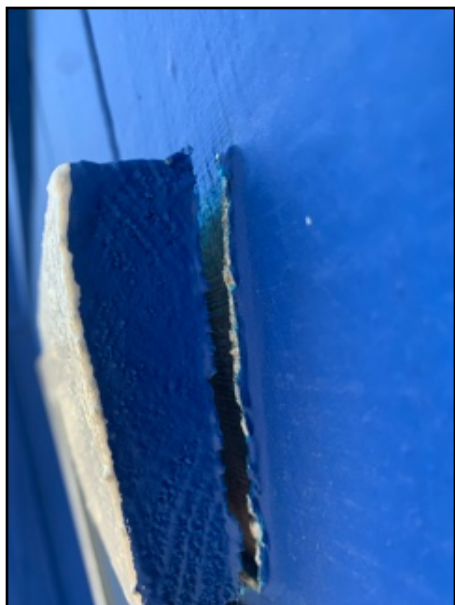
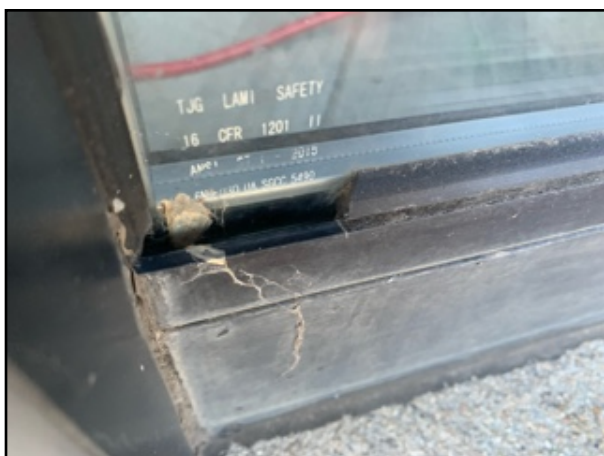
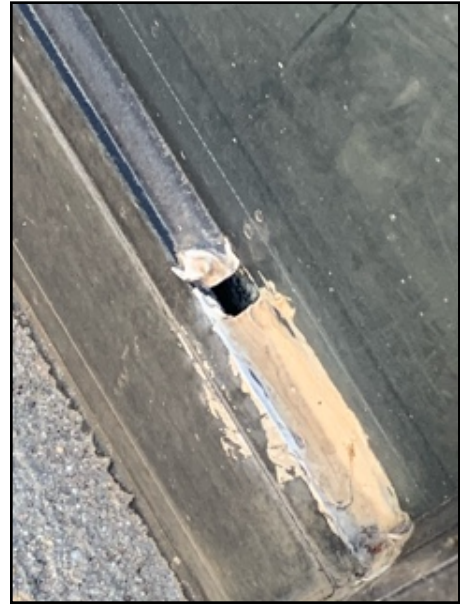
4) The exterior trim around windows is deteriorated. Gaps and cracks around windows need to be sealed. Which could allow water intrusion.

The exterior trim around windows is deteriorated. Gaps and cracks around windows need to be sealed. Which could allow water intrusion.

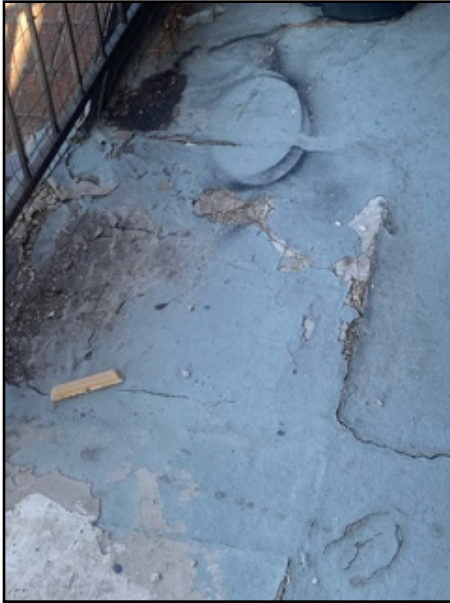
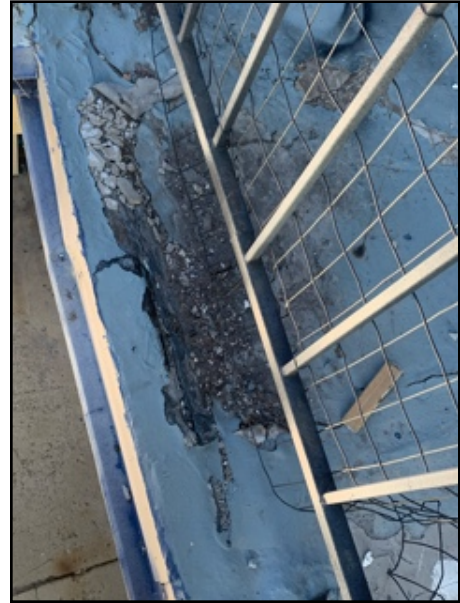
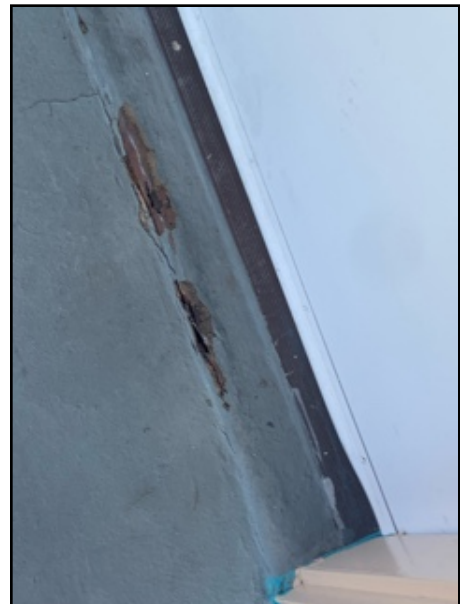
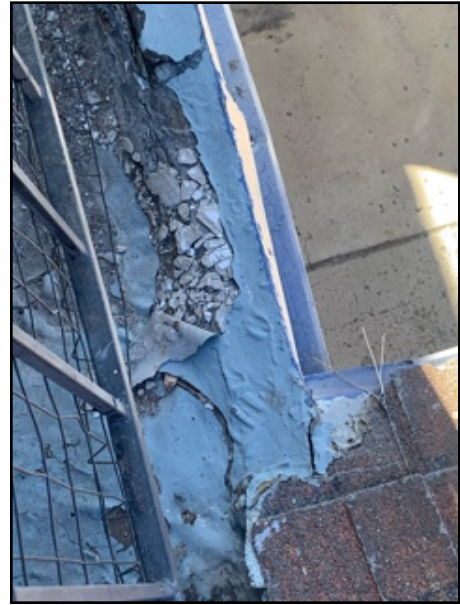
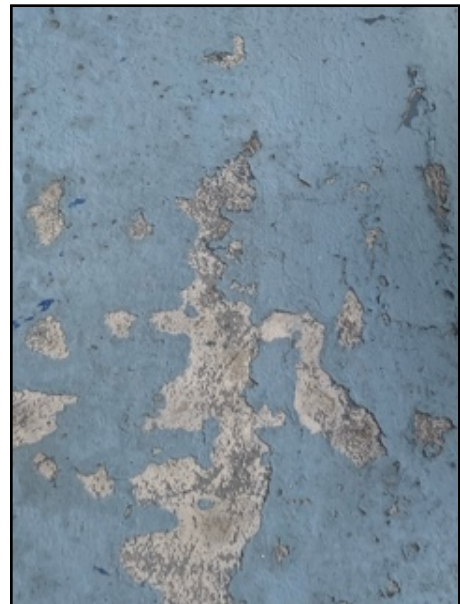
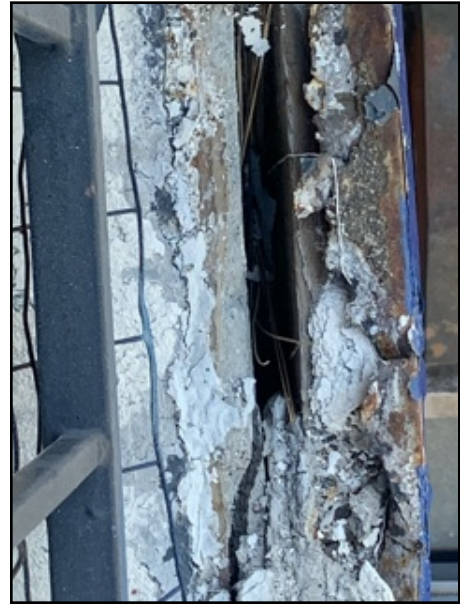
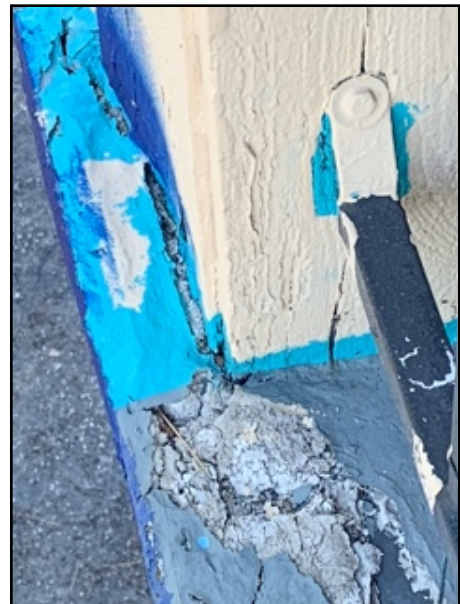
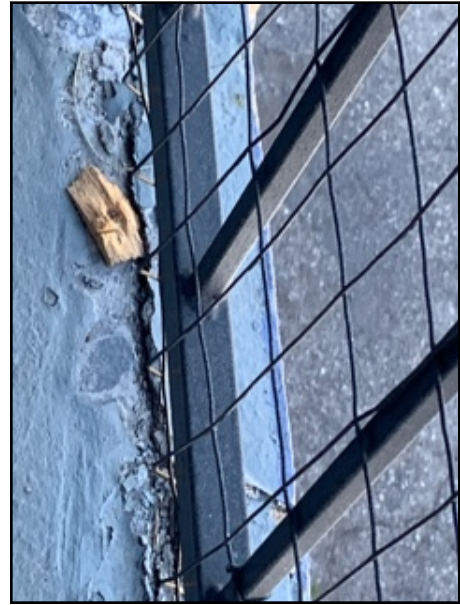
6) Safety Hazard. Balcony is damaged and need to repaired or replaced

Comment 6:  
Safety Hazard. Balcony is damaged and need to repaired or replaced

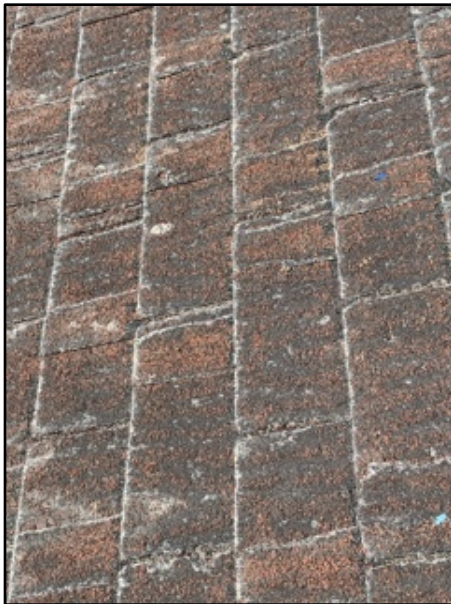
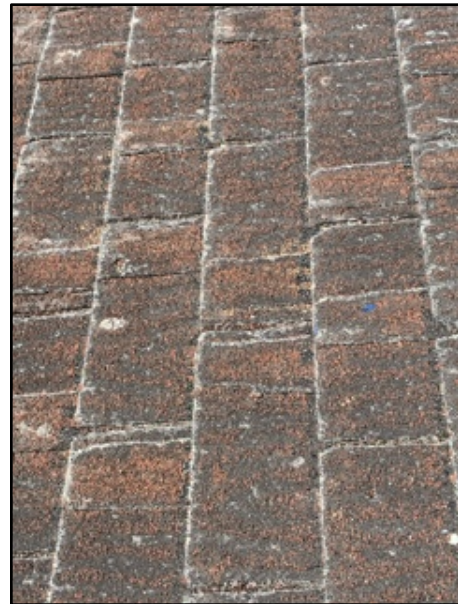
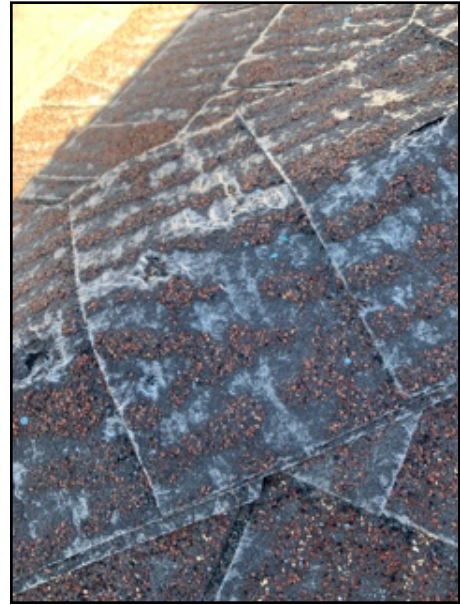
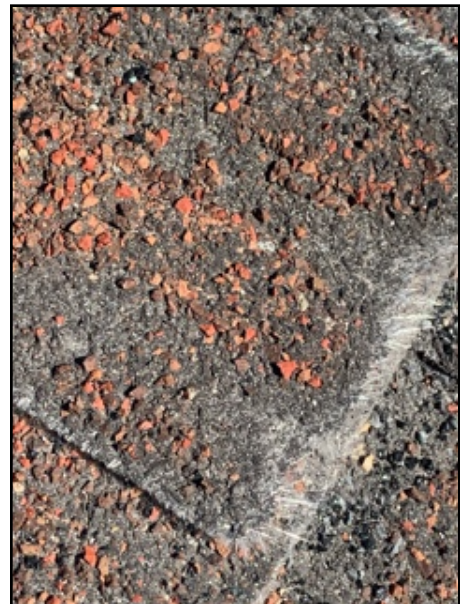
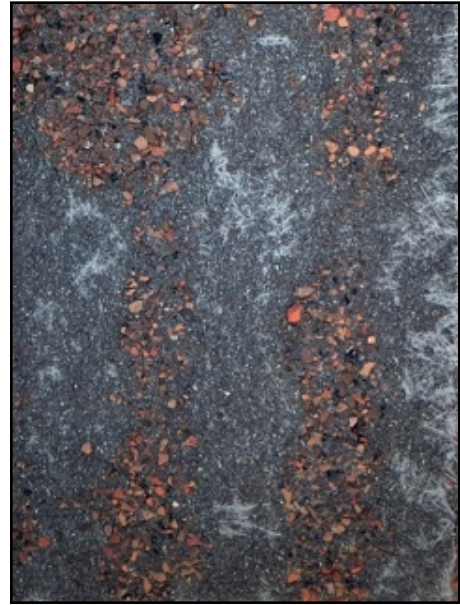
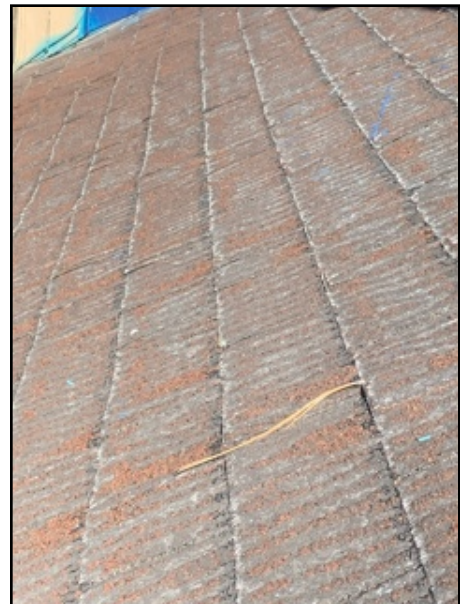
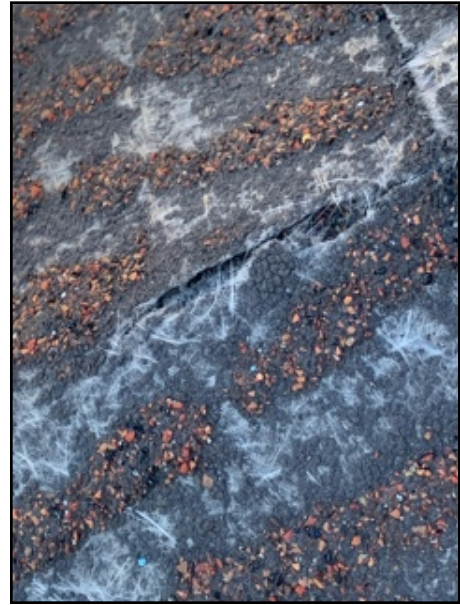
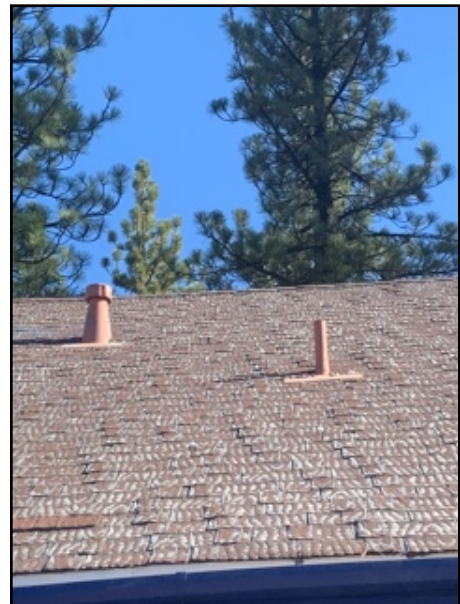
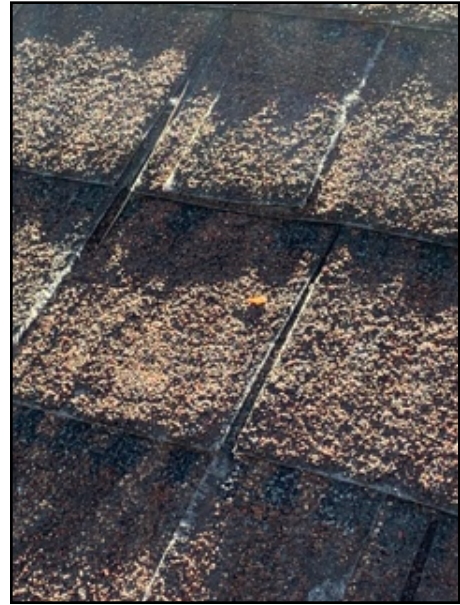
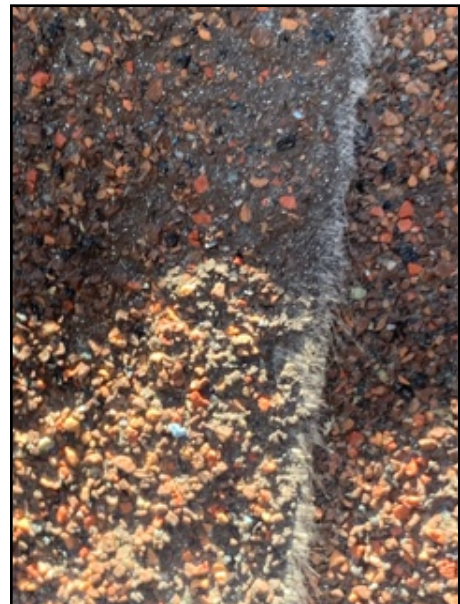
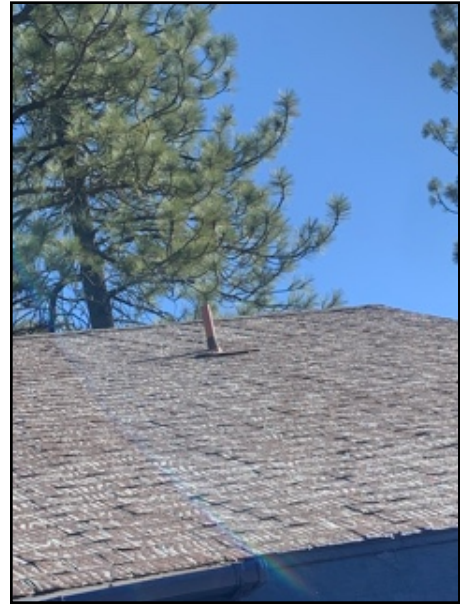
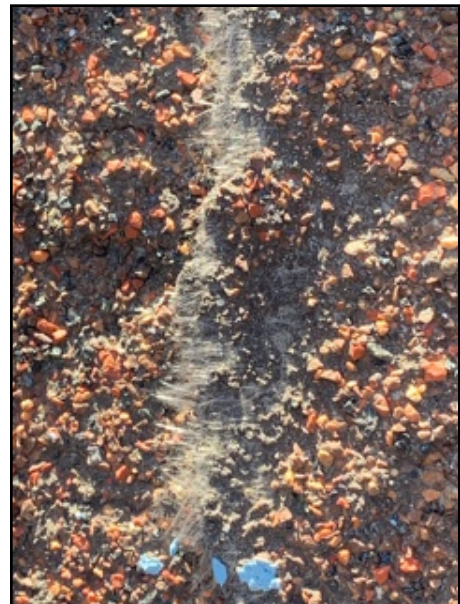
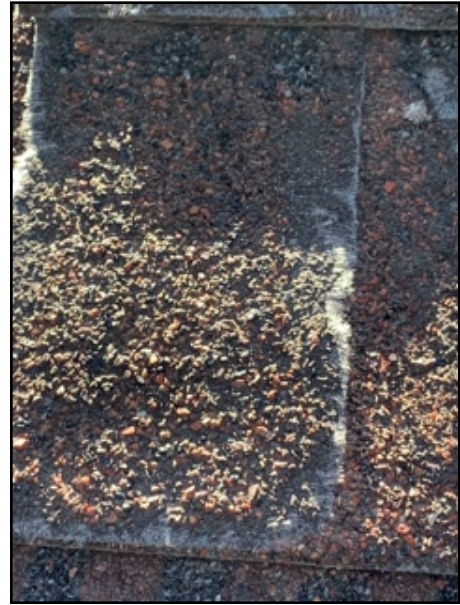
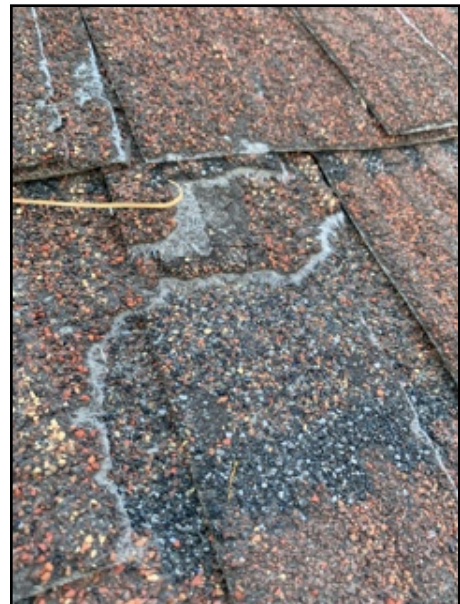
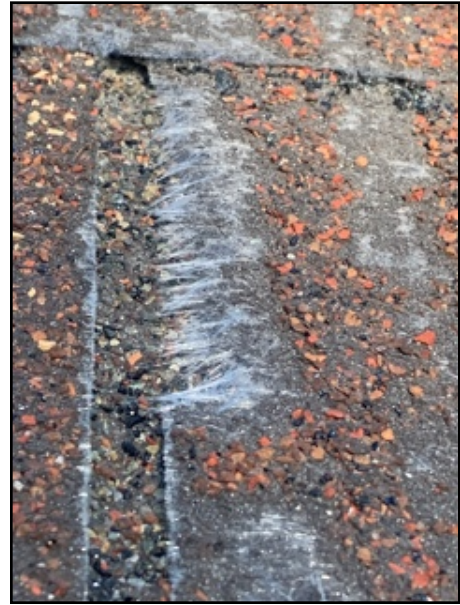
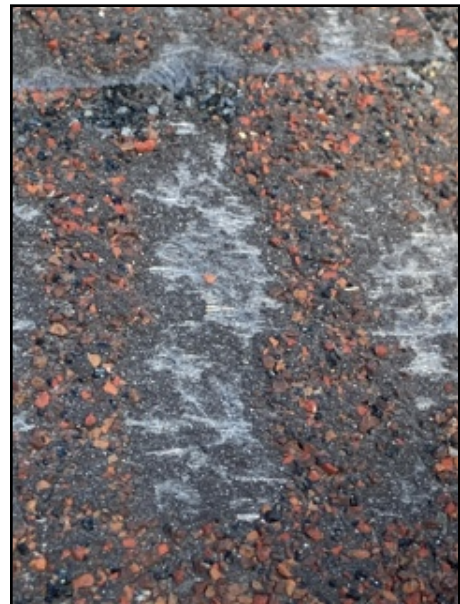
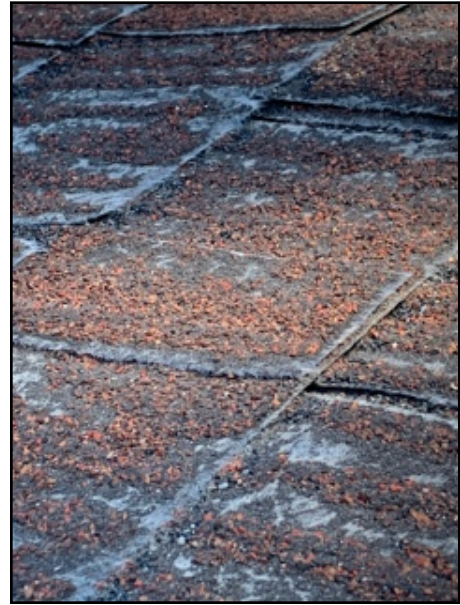
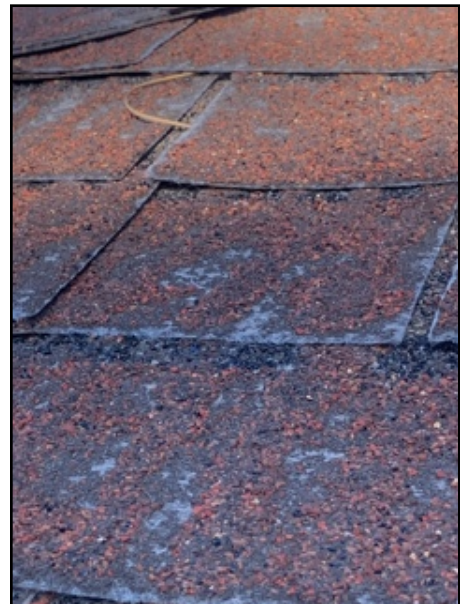
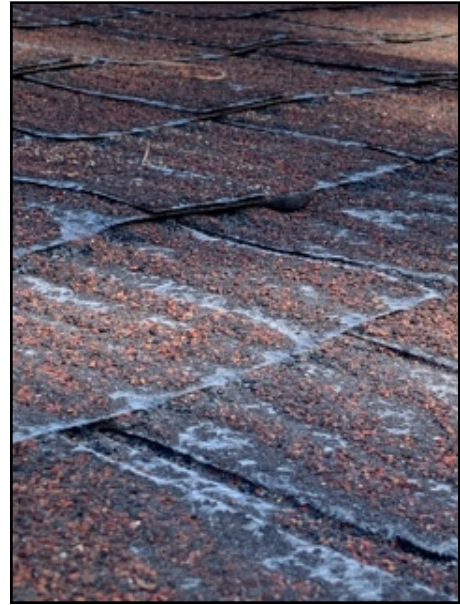
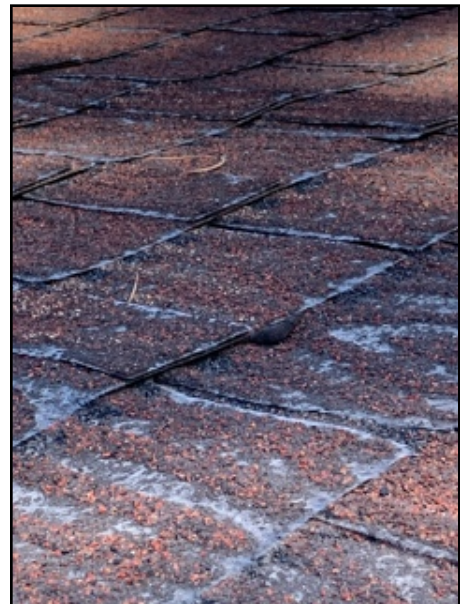
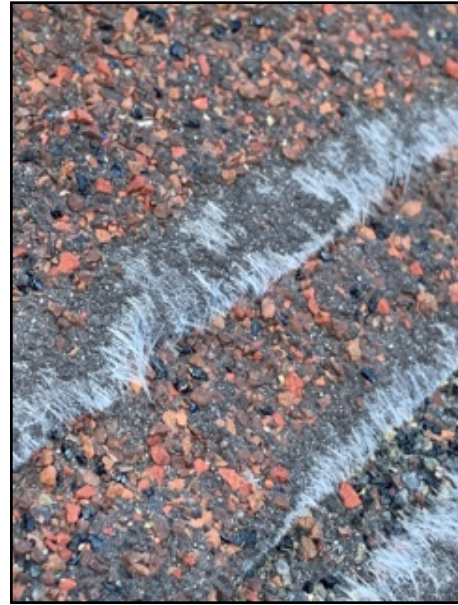
7) 2 of the 3 buildings roof need to be replaced. The roof surface is deteriorated and appeared to be at its service life.

This is a conducive condition for wood-destroying organisms. Consult with a qualified contractor to determine replacement options. Note that some structural repairs are often needed after old roof surfaces are removed and the structure becomes fully visible. Related roofing components such as flashings and vents should be replaced or installed as needed and per standard building practices.

2 of the 3 buildings roof need to be replaced. The roof surface is deteriorated and appeared to be at its service life.

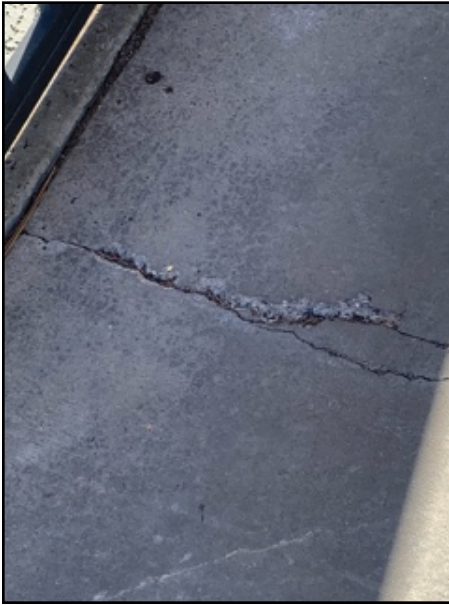
Figure 8-1

8) Recommend sealing opening around front of building near Big Bear Blvd Seal cracks around footing. Opening around foundation is causing Hydrostatic Pressure. The problems occur when the foundation begins to weaken. Foundations are commonly made of some form of concrete, which is a strong substance, but it is also porous.

Recommend sealing opening around front of building near Big Bear Blvd Seal cracks around footing. Opening around foundation is causing Hydrostatic Pressure. The problems occur when the foundation begins to weaken. Foundations are commonly made of some form of concrete, which is a strong substance, but it is also porous.

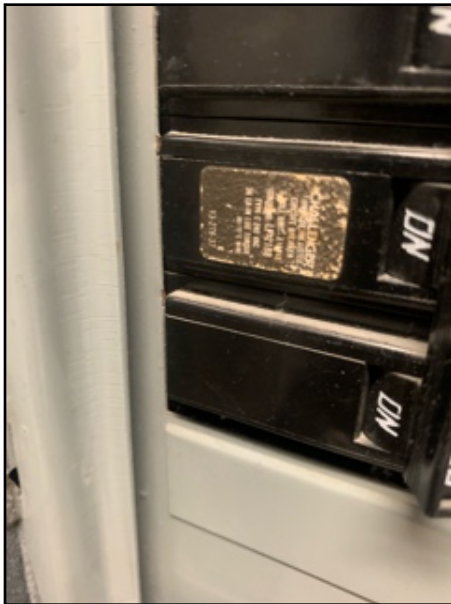
Figure 9-1

9) Panel in wash room Challenger breakers were installed in hundreds of thousands of homes during the 80's and 90's.

Over the years it was discovered that 2 types of circuit breakers manufactured by Challenger are overheating under NORMAL conditions at the connection point to the busbar. This causes expansion and contraction which in turn causes arcing between the circuit breaker and the busbar damaging both. This continues over time until these components actually melt down completely, causing hazardous conditions such as fire and/or shock hazard.

Panel in wash room Challenger breakers were installed in hundreds of thousands of homes during the 80's and 90's.

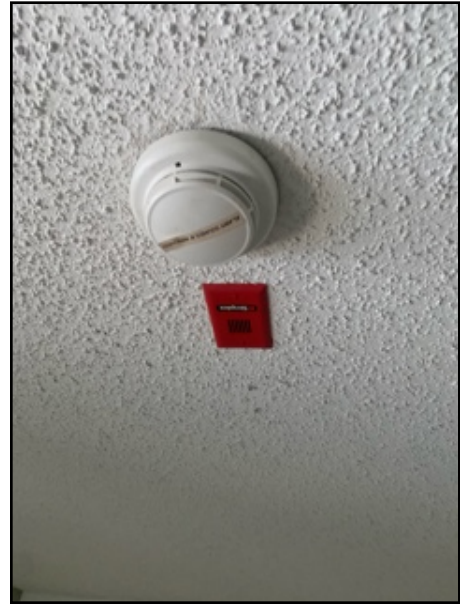
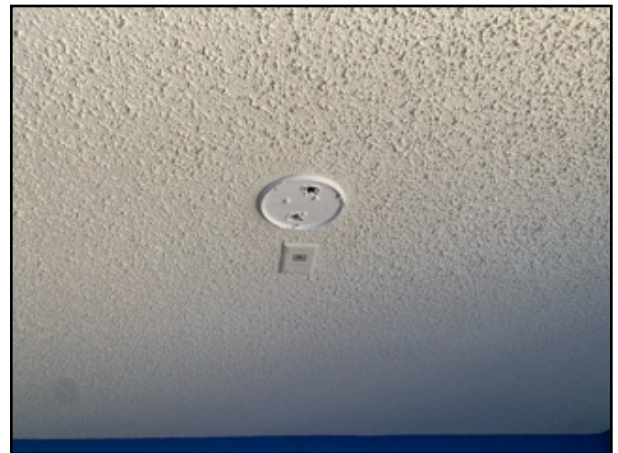
10) All smoke detectors. The life expectancy of smoke alarms is generally 10 years, after which point their sensors can begin to lose sensitivity. The test button only confirms that the battery, electronics, and alert system are working; it doesn't mean that the smoke sensor is working. Bedroom need smoke detector.

All smoke detectors. The life expectancy of smoke alarms is generally 10 years, after which point their sensors can begin to lose sensitivity. The test button only confirms that the battery, electronics, and alert system are working; it doesn't mean that the smoke sensor is working. Bedroom need smoke detector.

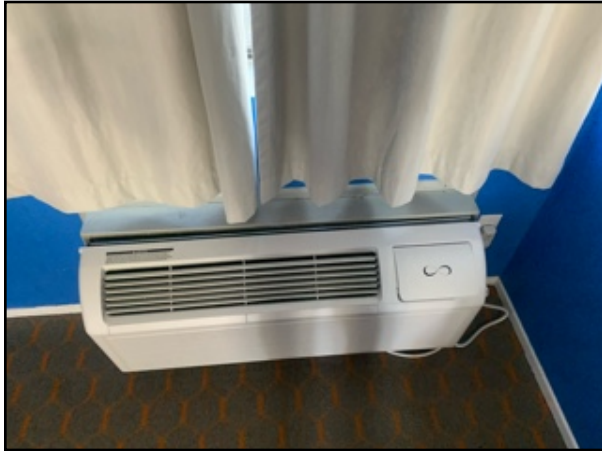
Figure 11-1

11) Recommend to budget for replacement. All units are older than 10 years old. PTAC stands for: "Packaged Thermal Air Conditioner". Industry survey revealed that with proper care, PTAC units could last up \ to ten years, but advancements in energy efficiency and smart technology may entice consumers to replace them every 5-7 years. R

Recommend to budget for replacement. All units are older than 10 years old. PTAC stands for: "Packaged Thermal Air Conditioner". Industry survey revealed that with proper care, PTAC units could last up \ to ten years, but advancements in energy efficiency and smart technology may entice consumers to replace them every 5-7 years. R

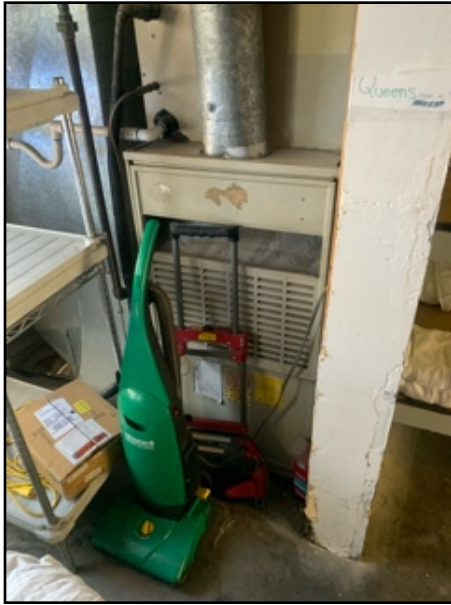
Figure 12-1

12) The estimated useful life for most forced air furnaces is 15-20 years. This furnace appeared to be near its useful lifespan. Recommend budgeting for a replacement in the future.

The estimated useful life for most forced air furnaces is 15-20 years. This furnace appeared to be near its useful lifespan. Recommend budgeting for a replacement in the future.

Approximate Age: Over 20 Years Old

Furnaces over 10 years old should be checked, cleaned and serviced yearly by a licensed contractor.

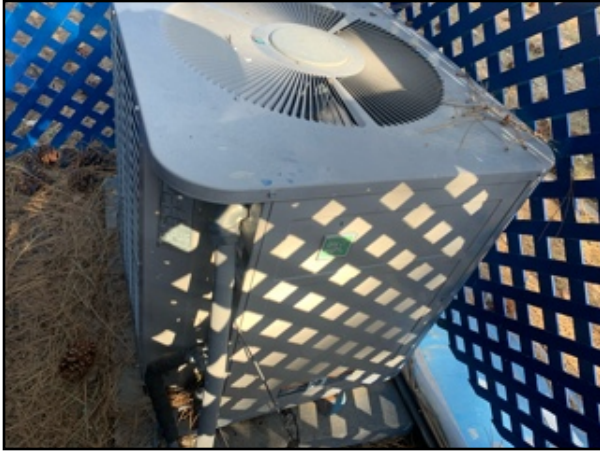
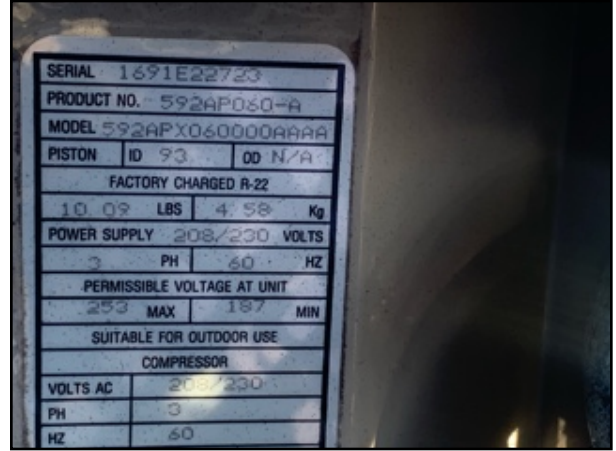
13) The estimated useful life for most A/C units is 15-20 years. This unit age is near it's useful lifespan and will need replacing or significant repairs at any time. Recommend budgeting for a replacement in the near future.

The estimated useful life for most A/C units is 15-20 years. This unit age is near it's useful lifespan and will need replacing or significant repairs at any time. Recommend budgeting for a replacement in the near future.

Condenser Approximate Age: Over 30 Years Old

Air conditioners over 10 years old and heat pumps over 5 years old should be checked, cleaned and serviced yearly by a licensed contractor.

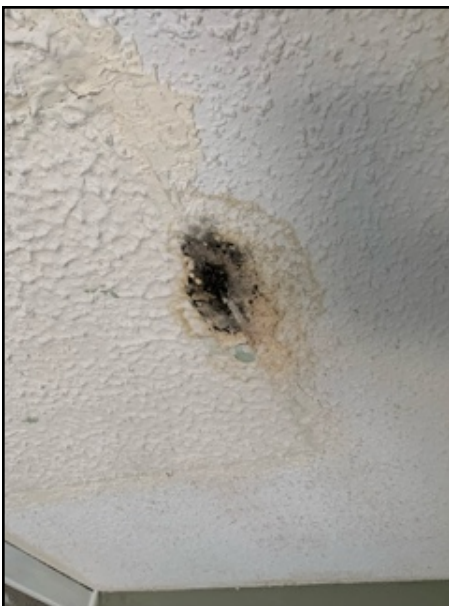
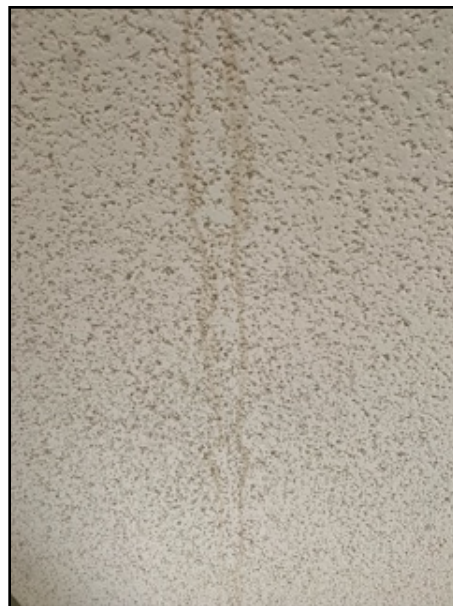
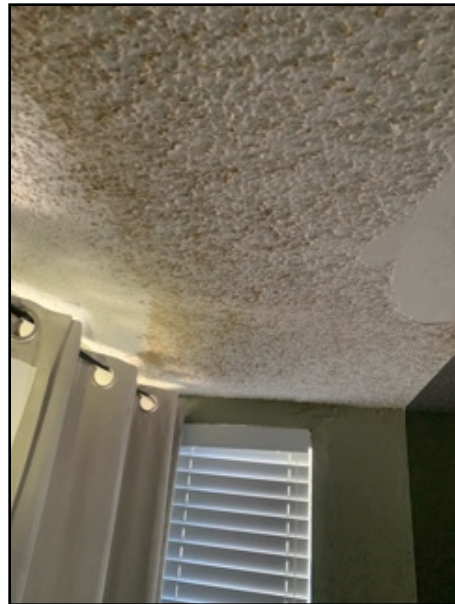
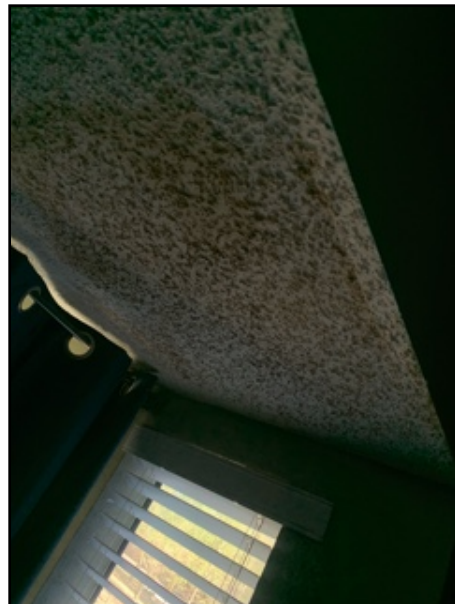
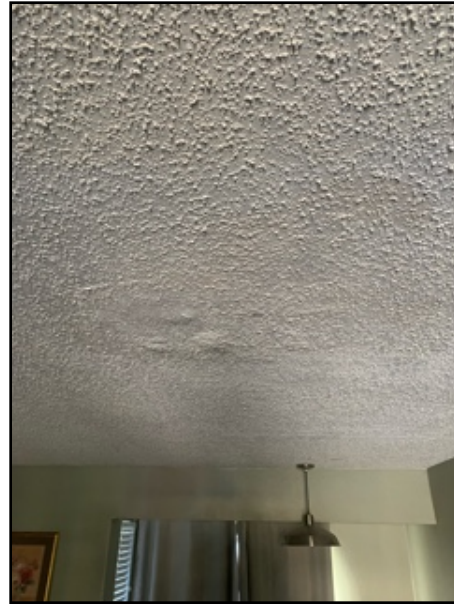
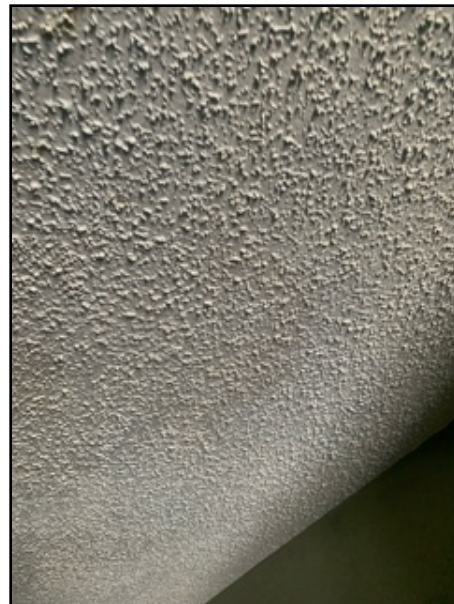
15) Moisture stains and water damage found 120,211 222,223,225,226.

Moisture stains and water damage found 120,211 222,223,225,226.

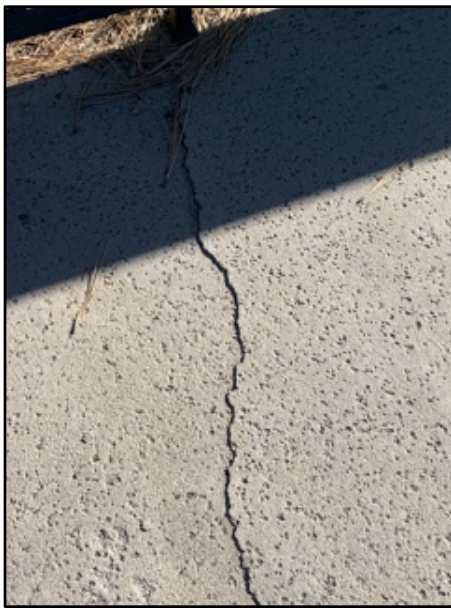
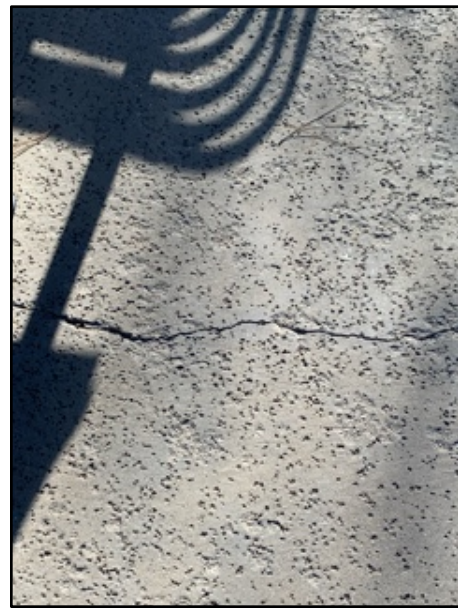
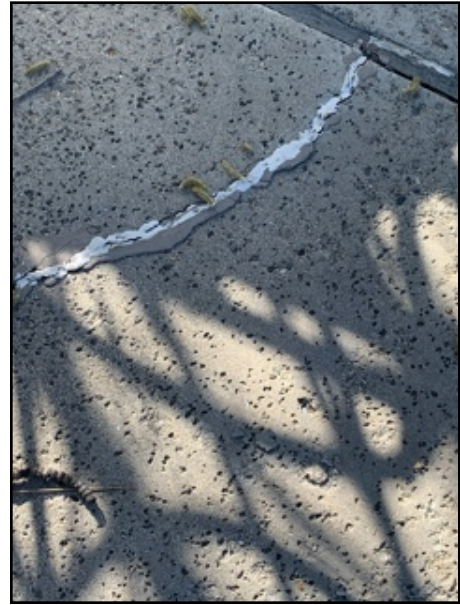
16) Cracks, holes, settlement, heaving and/or deterioration were found on the patio/deck. Recommend that qualified contractor repair as necessary.

Cracks, holes, settlement, heaving and/or deterioration were found on the patio/deck. Recommend that qualified contractor repair as necessary.

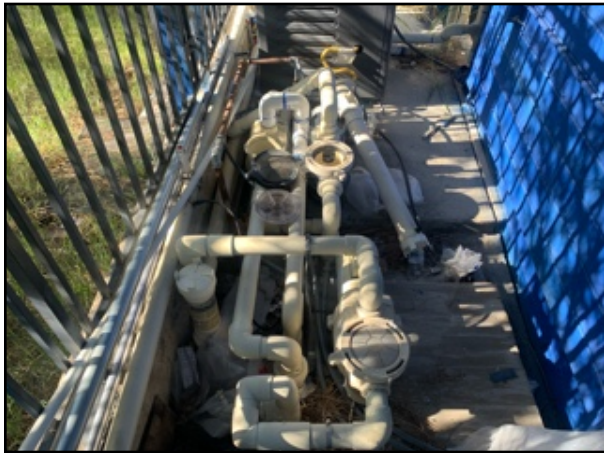
Figure 17-1

17) Recommend replacing filter, heater and pump. Due to the age of equipment. With regular use, most pool pumps last 8 to 12 years before needing replacement.

Recommend replacing filter, heater and pump. Due to the age of equipment. With regular use, most pool pumps last 8 to 12 years before needing replacement.

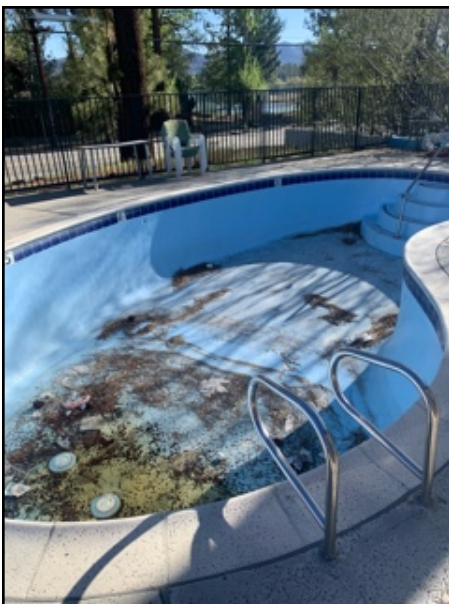
Figure 18-1

18) The pool surface shows signs of wear, stains and aging. Recommend a qualified pool contractor for further evaluation or repair

The pool surface shows signs of wear, stains and aging. Recommend a qualified pool contractor for further evaluation or repair
