# California Commercial Property Inspectors

## Commercial Inspection

**39471 Big Bear Blvd**

Inspected on Thu, May 19 2022 at 12:32 PM

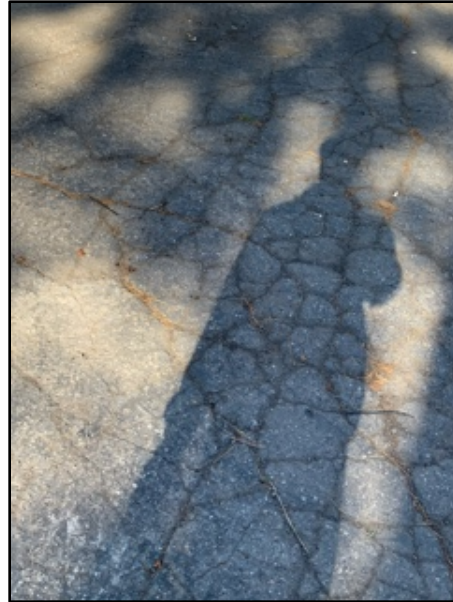
Figure 3-2

3) Cracks, holes, settlement, heaving and/or deterioration were found in the driveway. Trip Hazard. Recommend that qualified contractor repair as necessary.

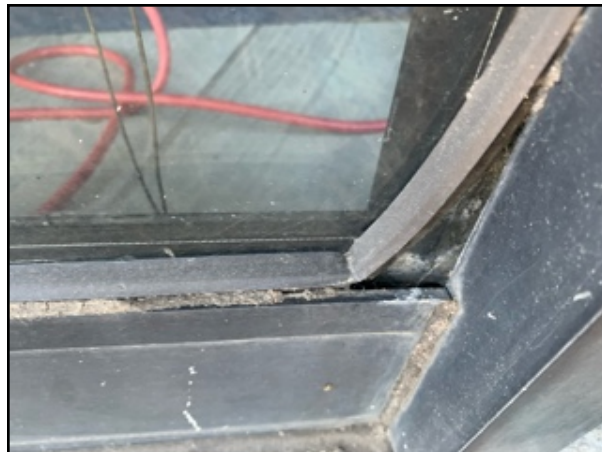
Figure 4-2

4) The exterior trim around windows is deteriorated. Gaps and cracks around windows need to be sealed. Which could allow water intrusion.

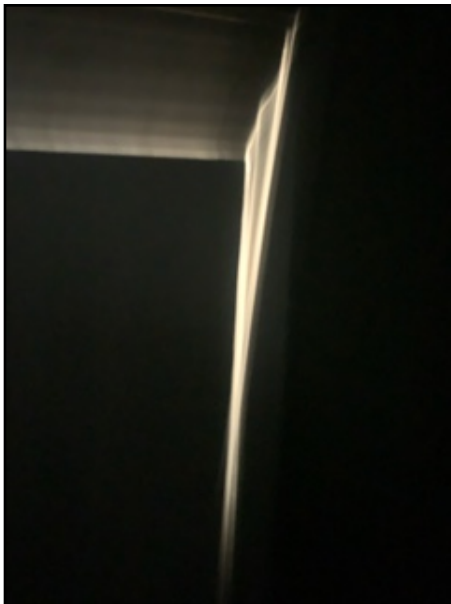
Figure 5-1

The exterior door reveals daylight at threshold.

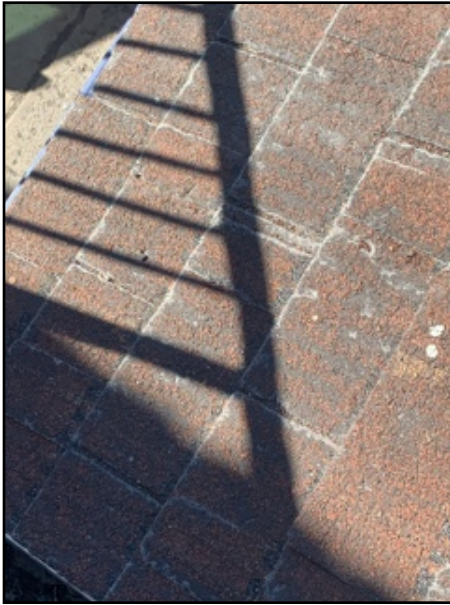
Figure 7-3

7) 2 of the 3 buildings roof need to be replaced. The roof surface is deteriorated and appeared to be at its service life.

This is a conducive condition for wood-destroying organisms. Consult with a qualified contractor to determine replacement options. Note that some structural repairs are often needed after old roof surfaces are removed and the structure becomes fully visible. Related roofing components such as flashings and vents should be replaced or installed as needed and per standard building practices.

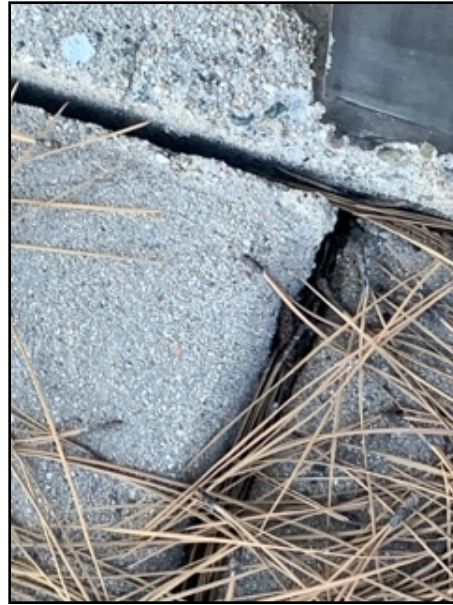
Figure 8-2

Recommend sealing opening around front of building near Big Bear Blvd Seal cracks around footing. Opening around foundation is causing Hydrostatic Pressure. The problems occur when the foundation begins to weaken. Foundations are commonly made of some form of concrete, which is a strong substance, but it is also porous.

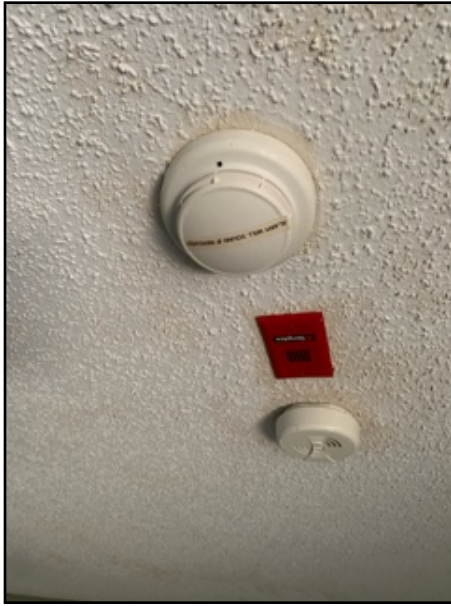
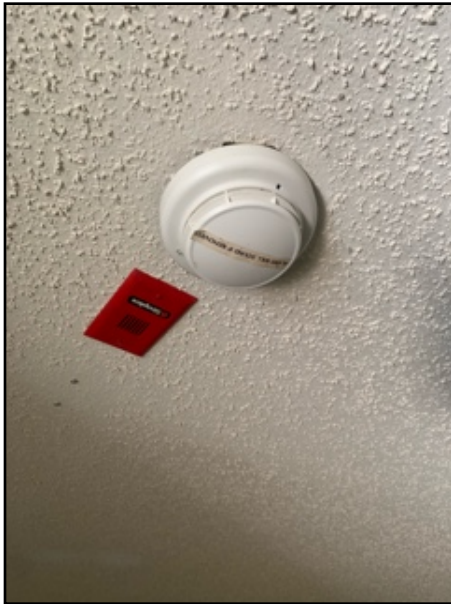
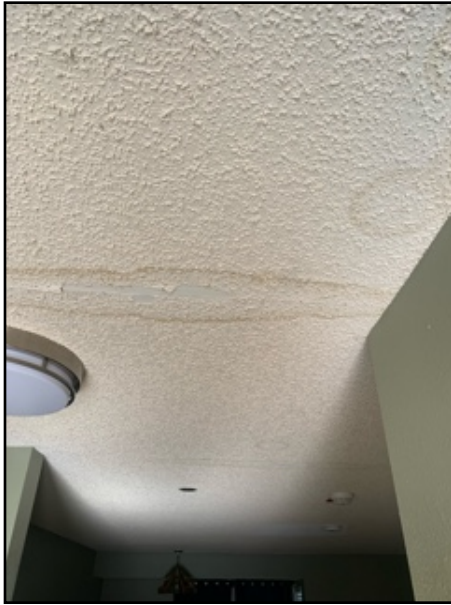
All smoke detectors. The life expectancy of smoke alarms is generally 10 years, after which point their sensors can begin to lose sensitivity. The test button only confirms that the battery, electronics, and alert system are working; it doesn't mean that the smoke sensor is working. Bedroom need smoke detector.

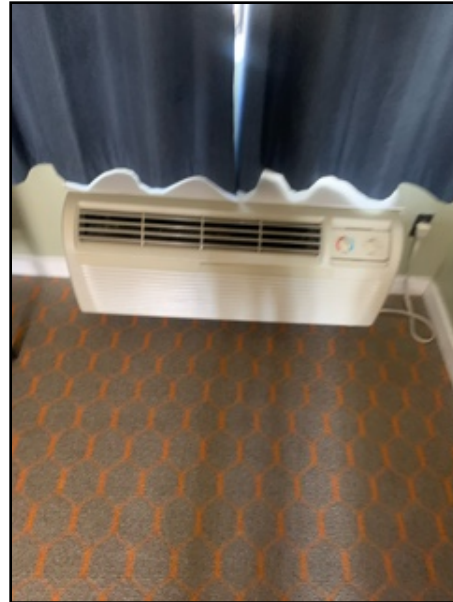
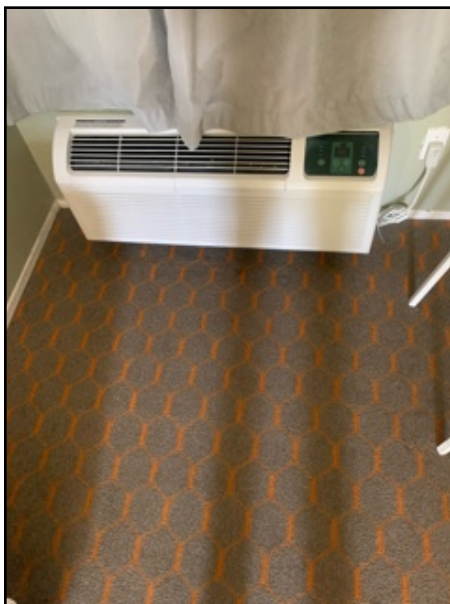
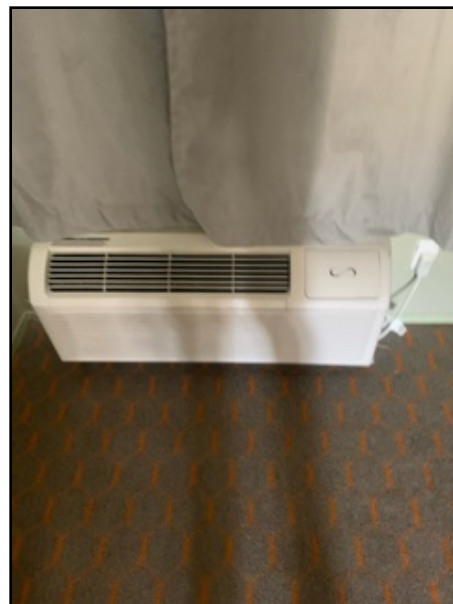
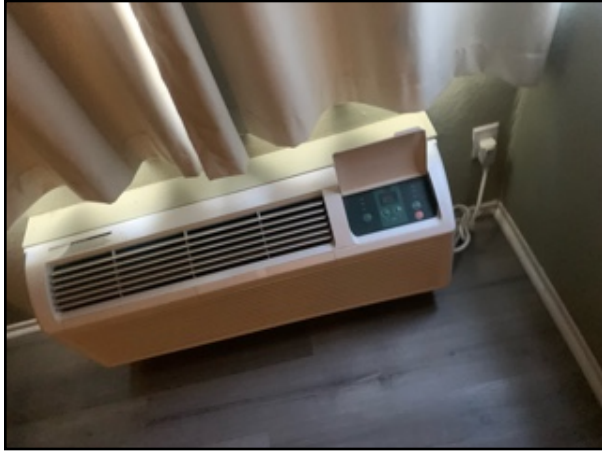
Recommend to budget for replacement. All units are older than 10 years old. PTAC stands for: "Packaged Thermal Air Conditioner". Industry survey revealed that with proper care, PTAC units could last up \ to ten years, but advancements in energy efficiency and smart technology may entice consumers to replace them every 5-7 years. R

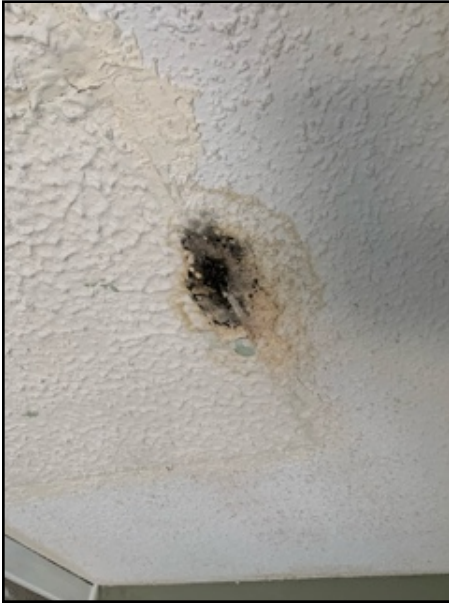
Figure 14-1

What appears to be Microbial growth on ceiling in room 120.

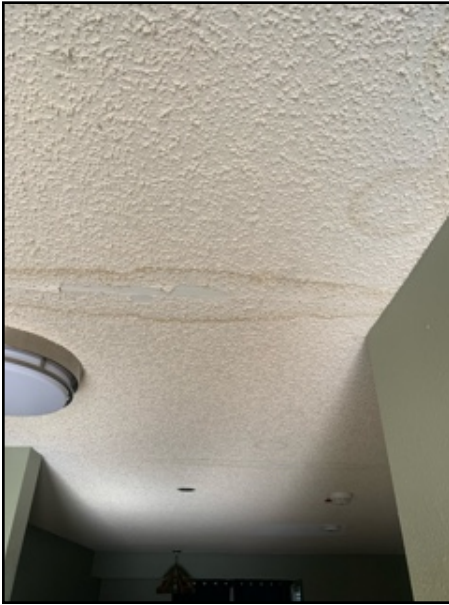
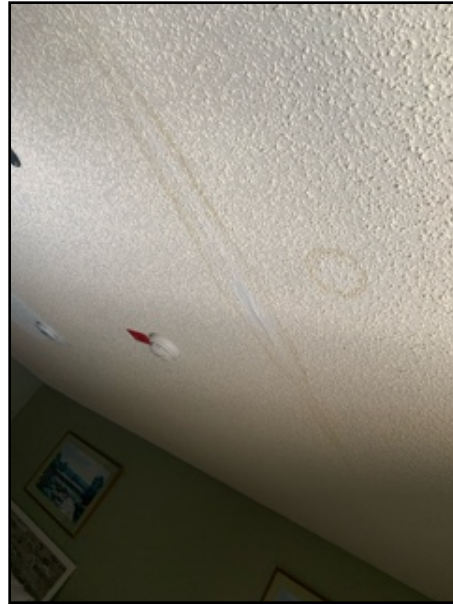
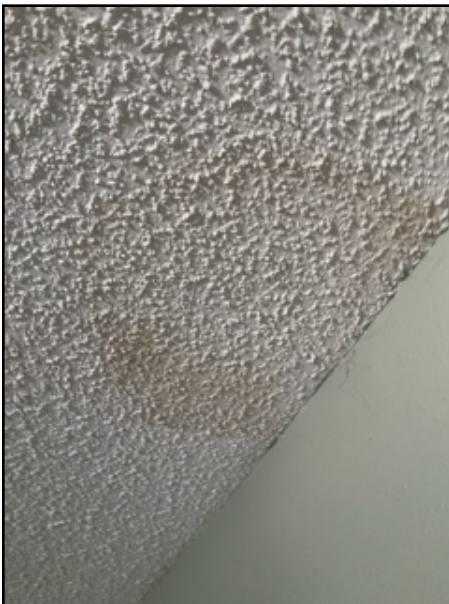
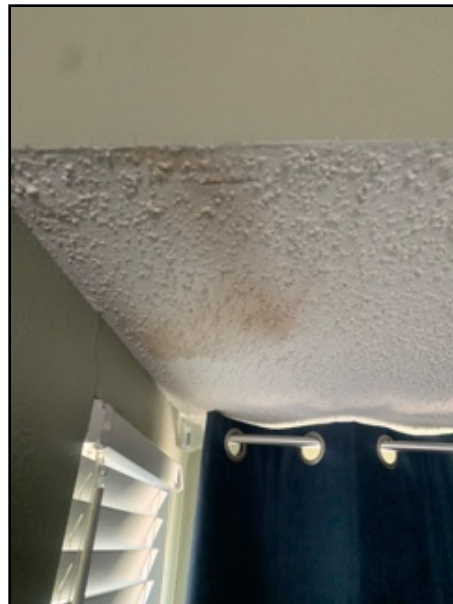
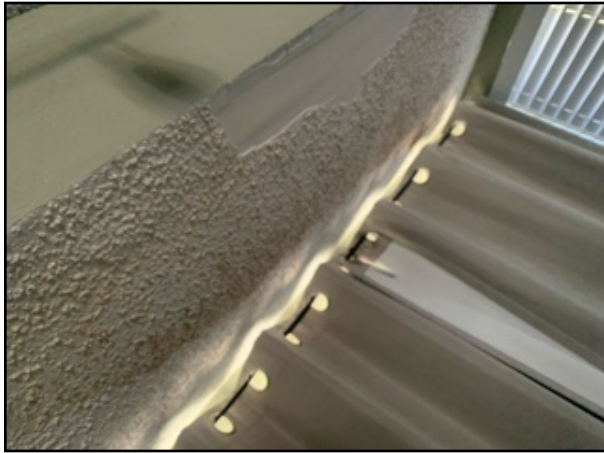
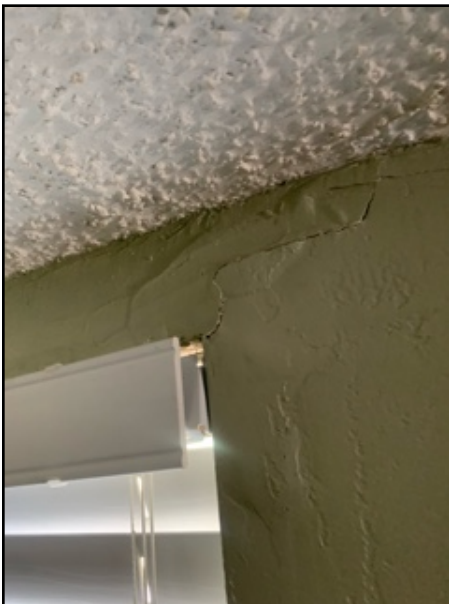
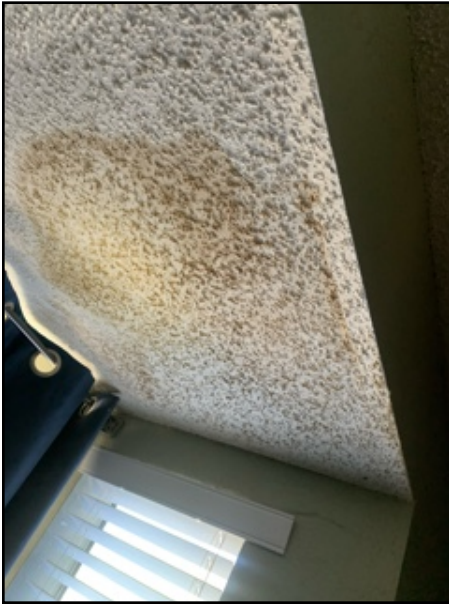
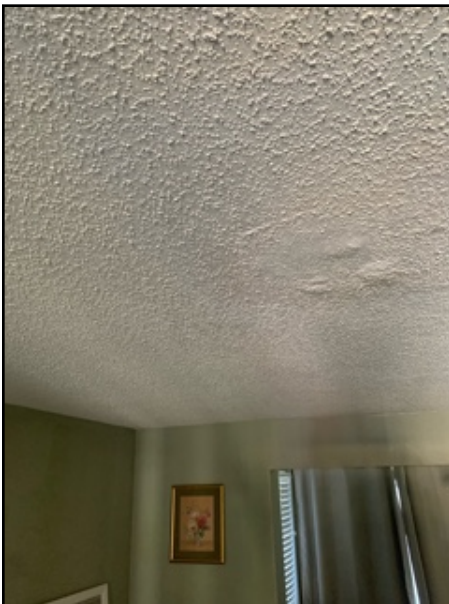
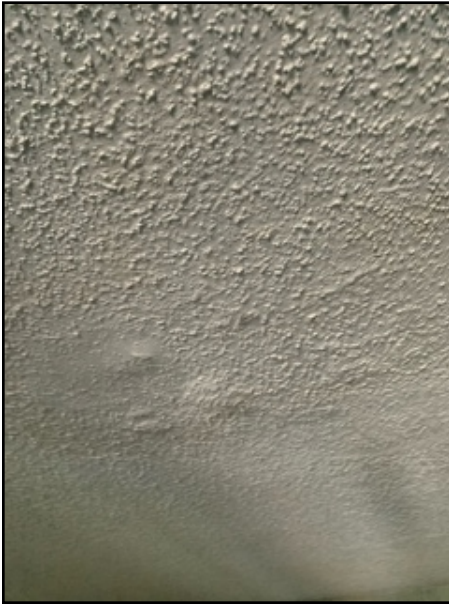
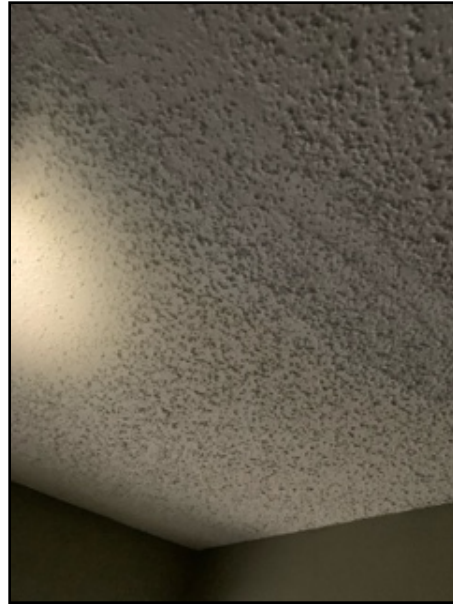
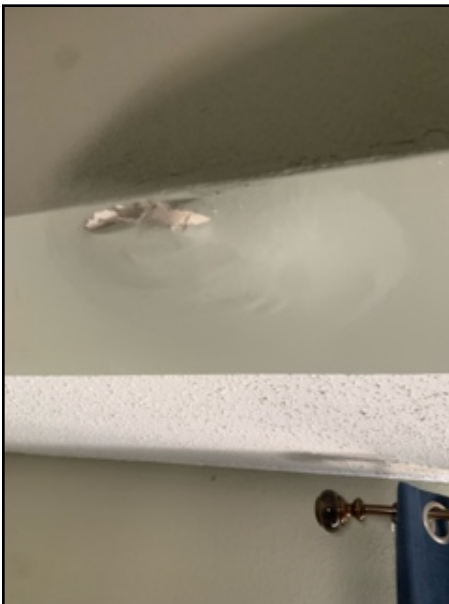
Moisture stains and water damage found 120,211 222,223,225,226.

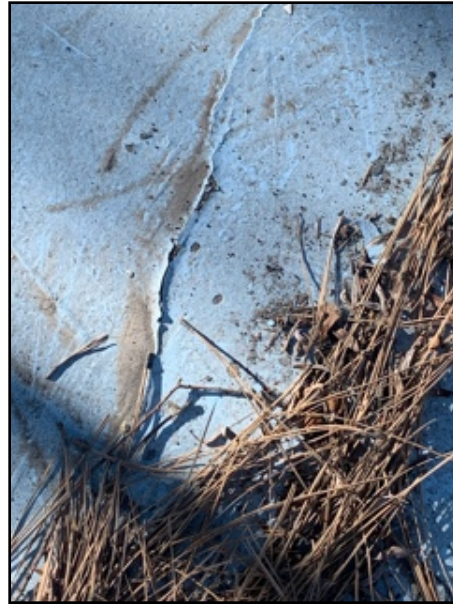
Figure 18-4

The pool surface shows signs of wear, stains and aging. Recommend a qualified pool contractor for further evaluation or repair
